SULLIVAN RESIDENCE
 620 ADMIRALY PARADE
 PORT ROYAL NAPLES, FL PERMIT 08-15-12

BCB – Sullivan’s Residence, 620 Admiralty Parade, Port Royal Naples, Florida

UNIT VV – SECOND FLOOR, SOUTH REAR ELEVATION

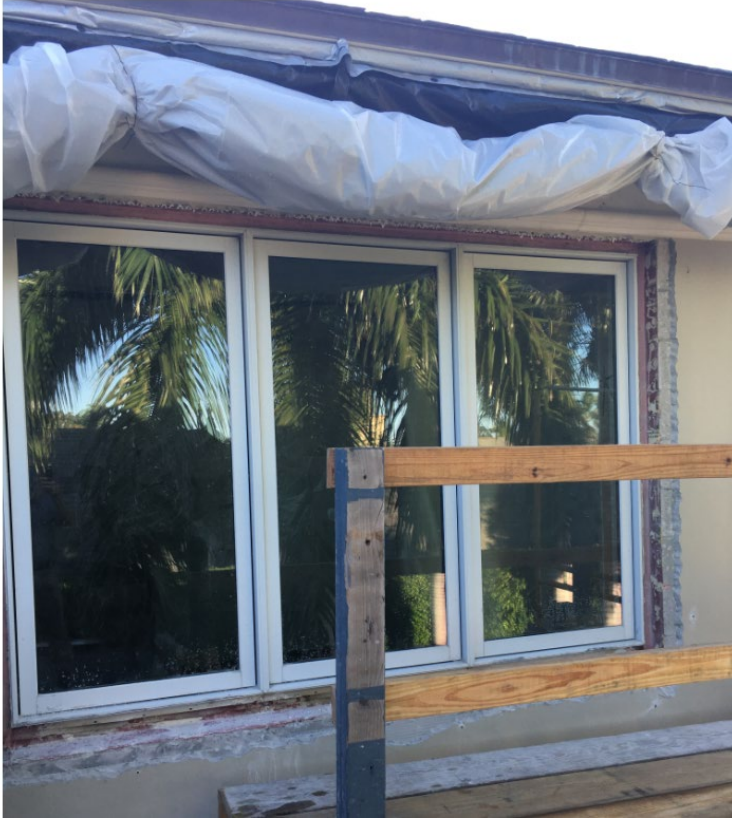
- Sides and top nail fin fastened with screws and ext. nail fin covered with Pink Joint & Seam Seal (Prosoco Product).

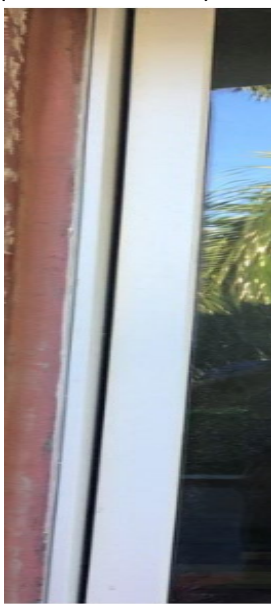
- Bottom Nail fin not screwed to buck via Loewen pre-drilled holes.

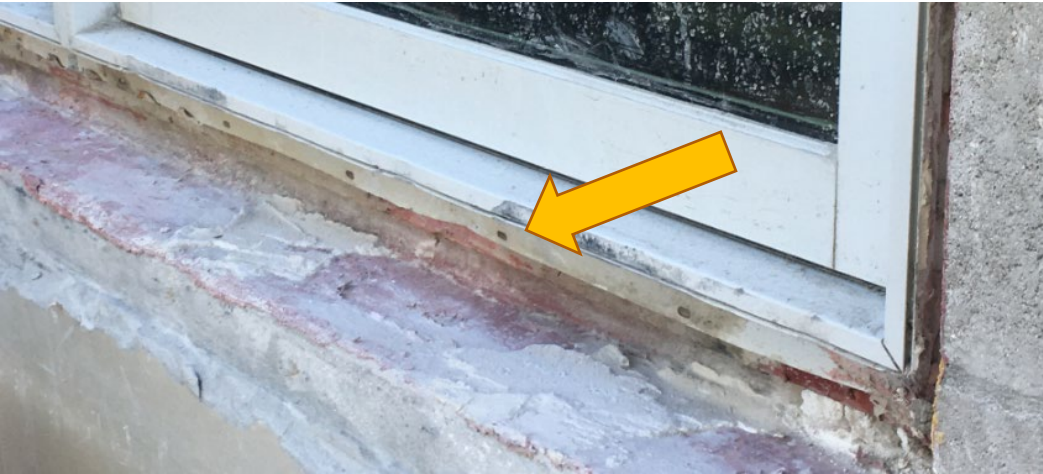
- Back of nail fin (underneath) had red/pink water proofing (Prosoco) including bottom nail fin.

- No sealant was applied to the back of the nail fins.

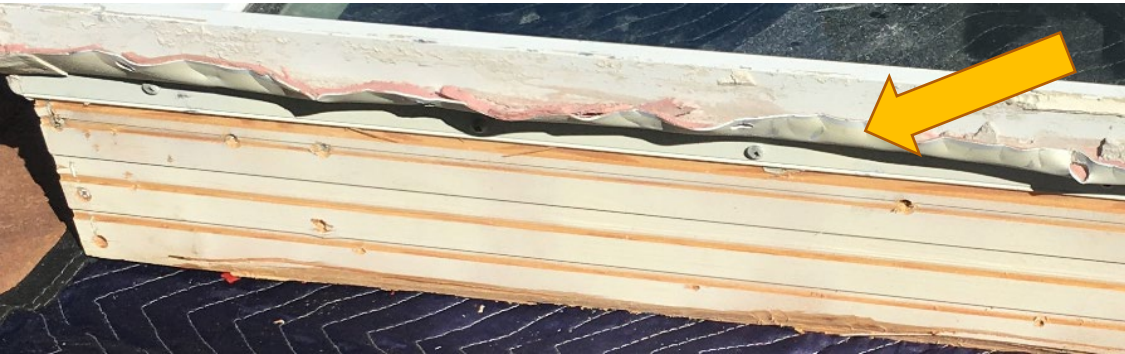
- Bucks with red waterproofing applied (Prosoco).

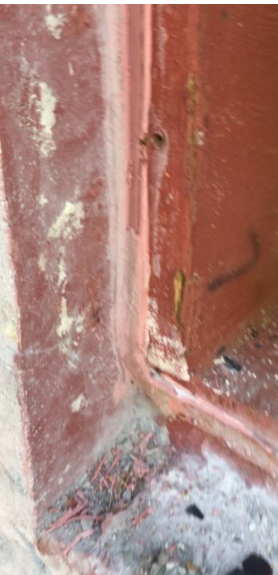
- Spots on pressure treated buck shows through to bare wood – Prosoco not uniformly and adequately applied.

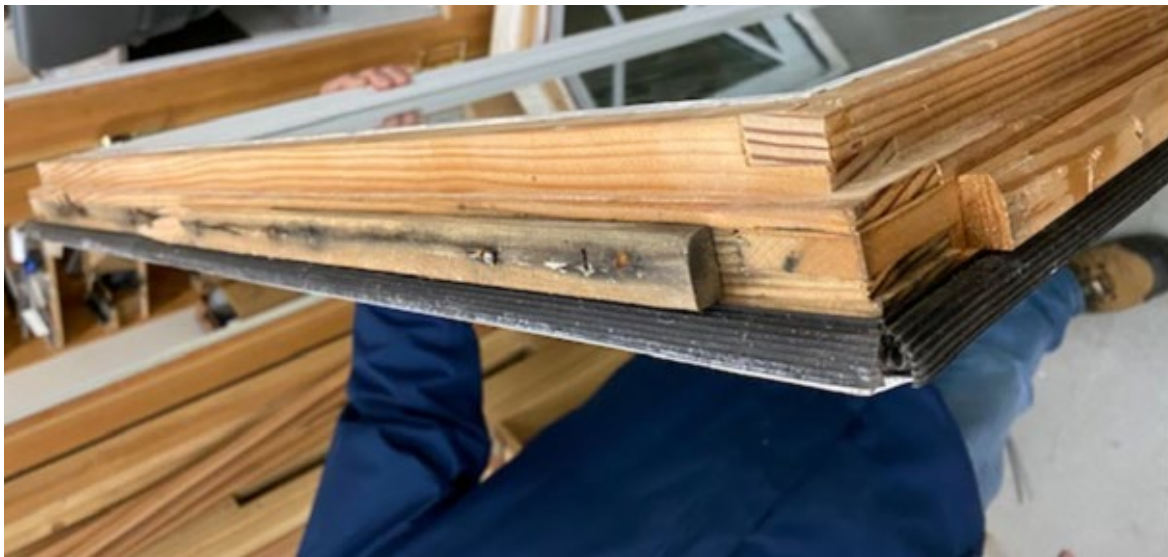
- Previous inspection with BCB in September 2020 - BCB probing method concluded that VV had signs of rot. This unit has no evidence of rot. VV had spacers that showed blackening. Some screws were rusted.
- Cause – bottom nail fin was not secured, and no sealant was applied.

No frame rot or sash rot on these units.

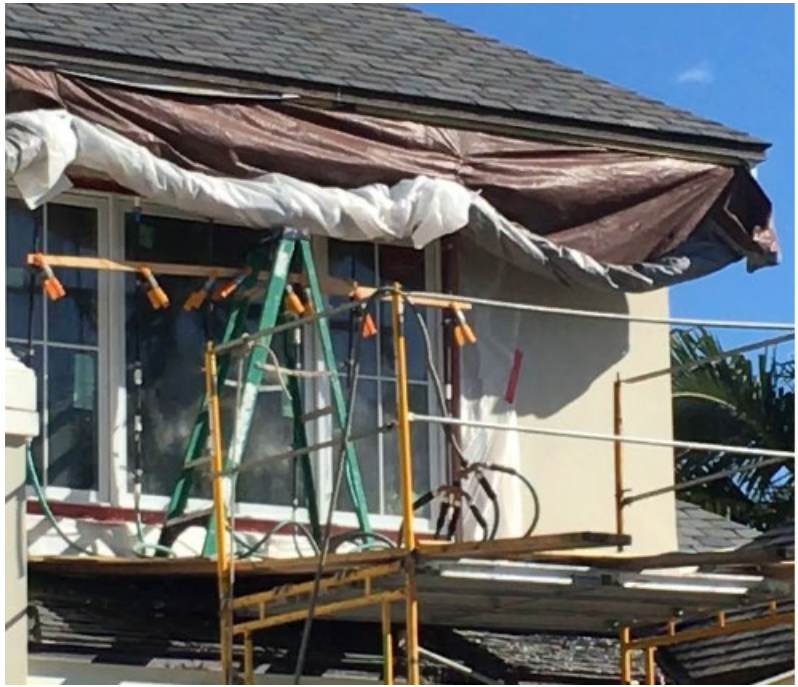
- Sides and top nail fin fastened with Screws and ext. nail fin covered with Pink Joint & Seam Seal (Prosoco Product).

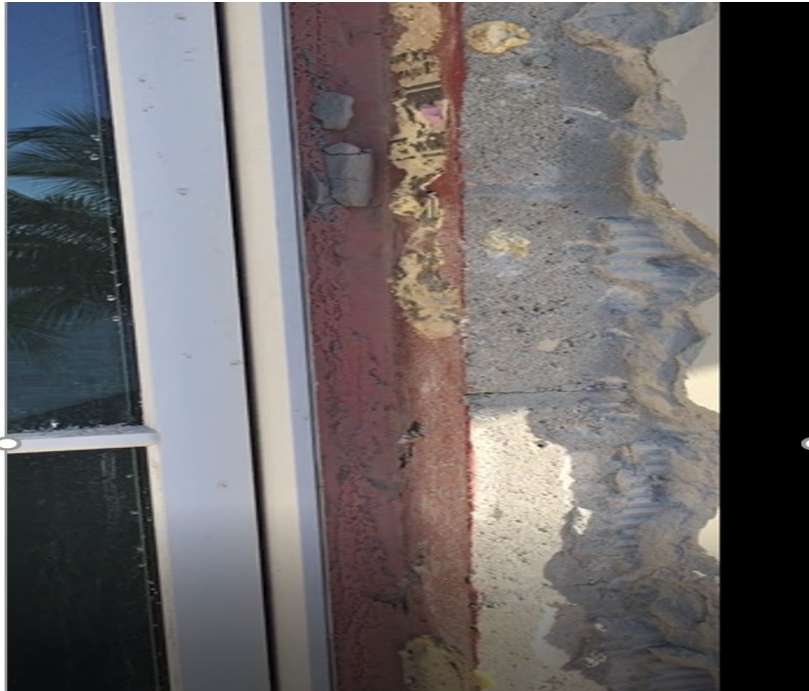
- Bottom nail fin not screwed to buck via Loewen pre-drilled holes.

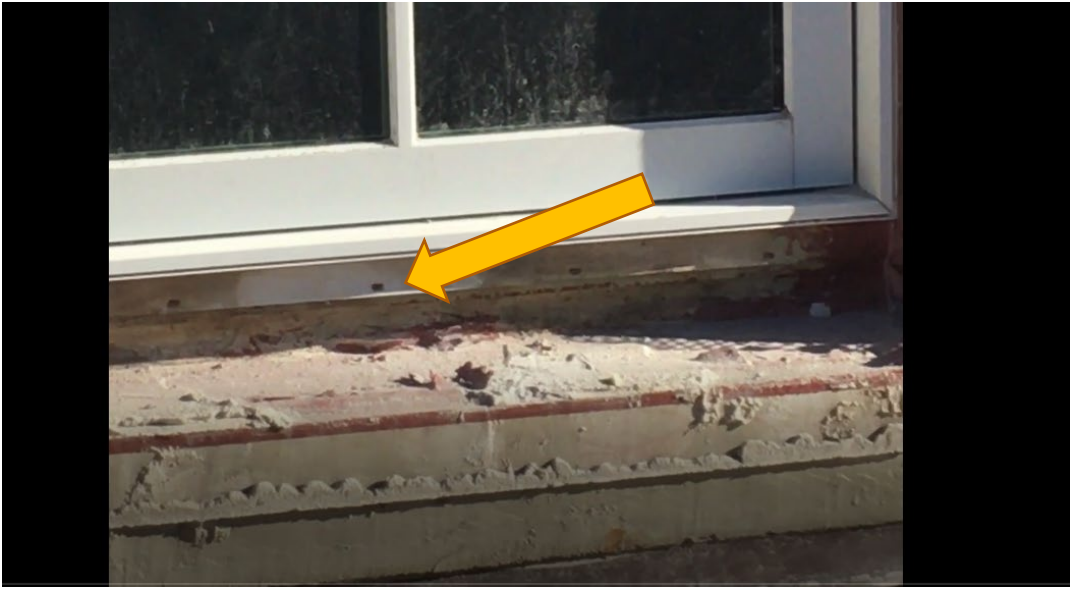
- Back of nail fin had red/pink waterproofing (Prosoco) including bottom nail fin – No sealant was applied to the back of the nail fins.
- Only sealant was waterproofing on the bucks. (Red Fast Flash Prosoco).

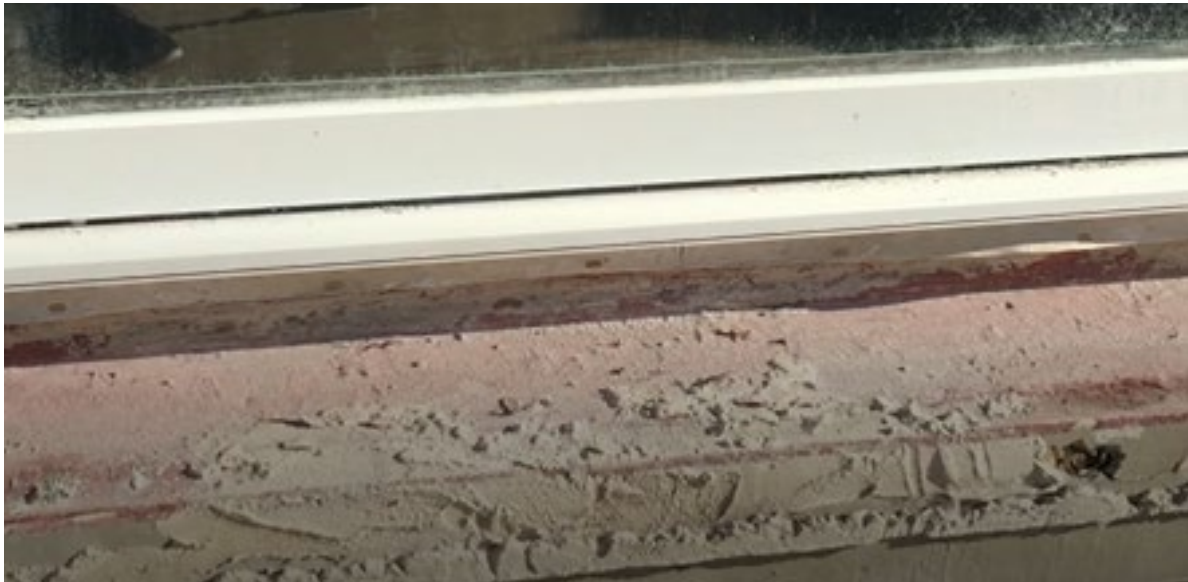
- Spots on pressure treated buck shows through to bare wood – Prosoco not uniformly and adequately applied.

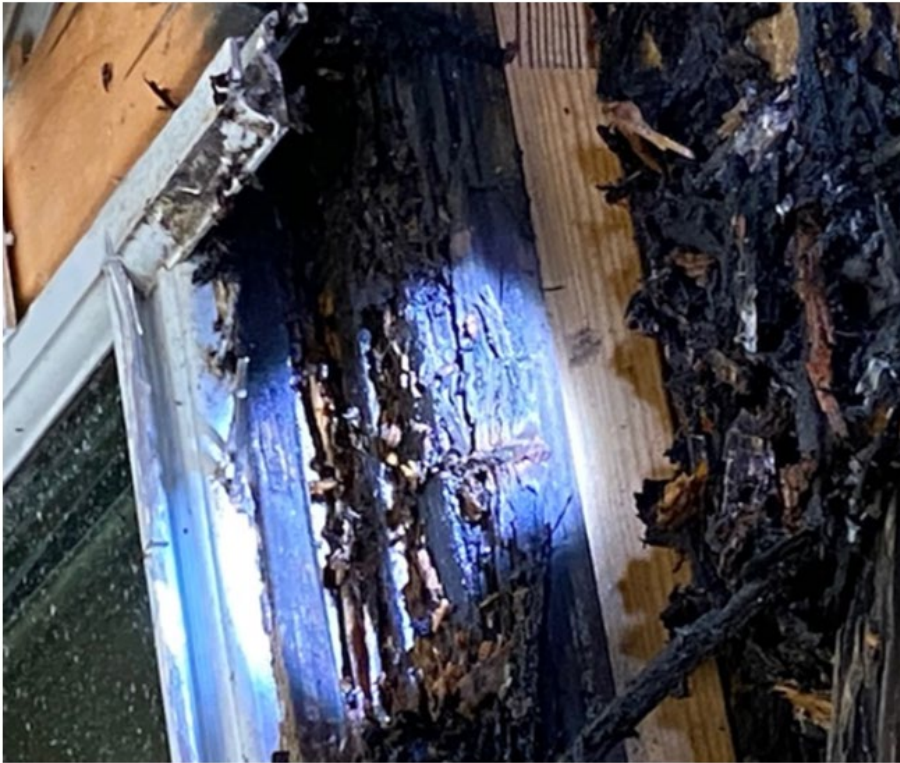
- Middle fixed unit – shows signs of water infiltration.
- The fixed unit was reglazed by Engler in July, 2019 due to seal failure.
- The glass on this unit was replaced and reglazed only.

- Water infiltration. Cause of tape separation unknown. This would have been detected through regular inspections.

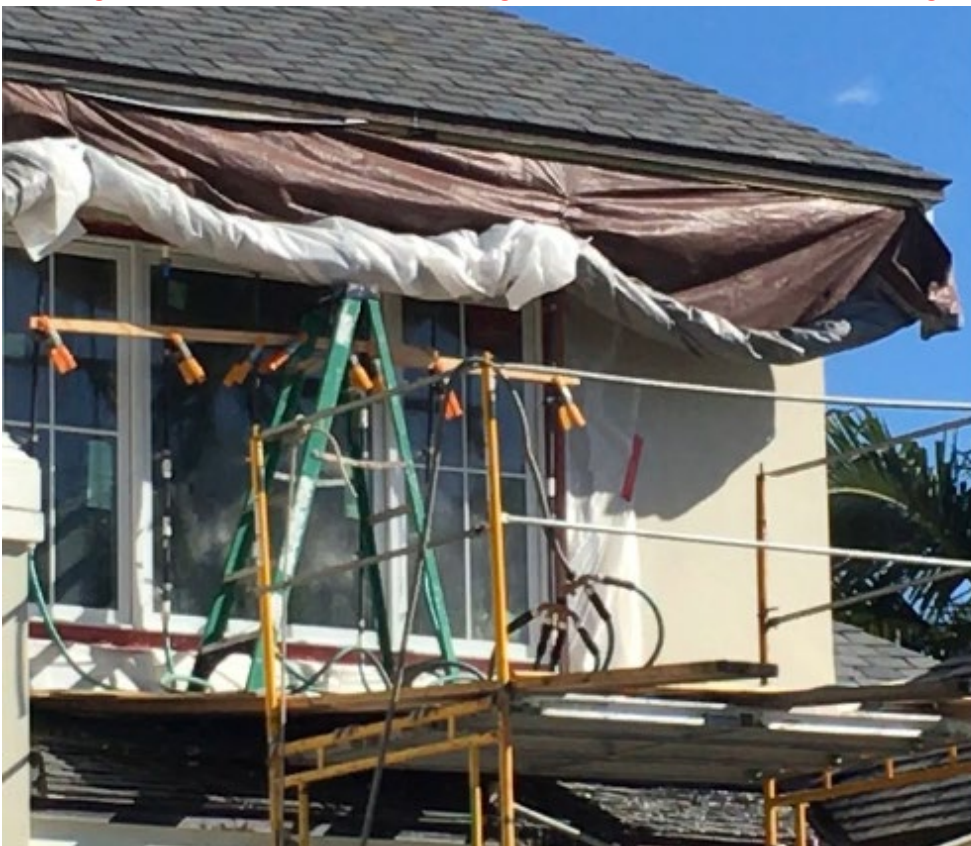
- Lack of gutters above window contributing to flow of water to windows during inclement weather.

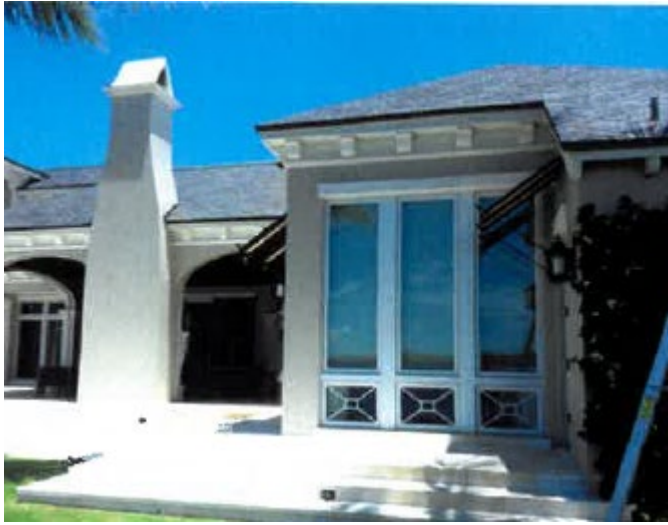
- No drip cap over mulls.

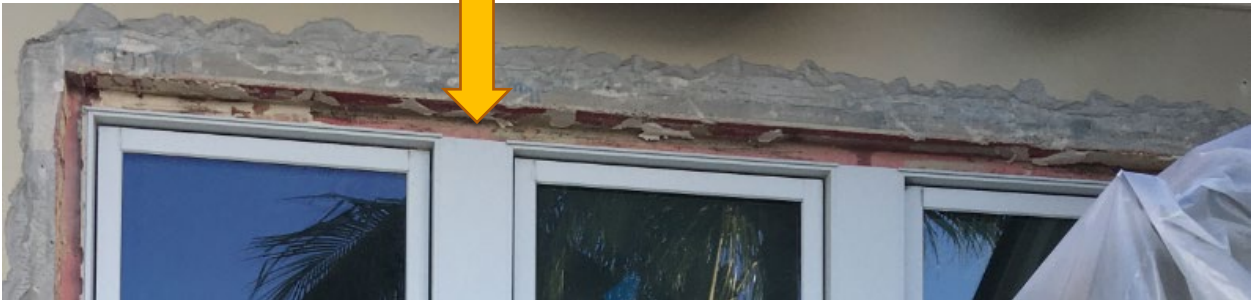
- Three top windows - entire nail fin screwed completely around perimeter.
- Bottom nail fin not screwed to buck via Loewen pre-drilled holes.

- Pink Joint & Seam Seal waterproofing covering nail fin on top three windows.
- Pink Joint & Seam Seal waterproofing covering nail fin on bottom three sides of window only.
- Pink Joint & Seam Seal waterproofing not complete on bottom nail fin of bottom windows, nail fin not attached.

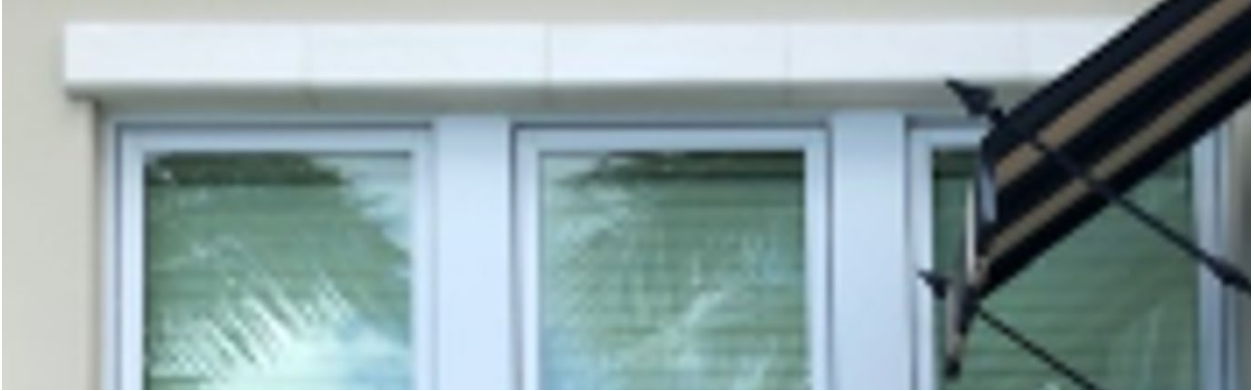
- Lack of gutters above window contributing to flow of water to windows during inclement weather. Positioning and angle of Awning over door directs all water flow during inclement weather directly in line with the center unit of the grouping.

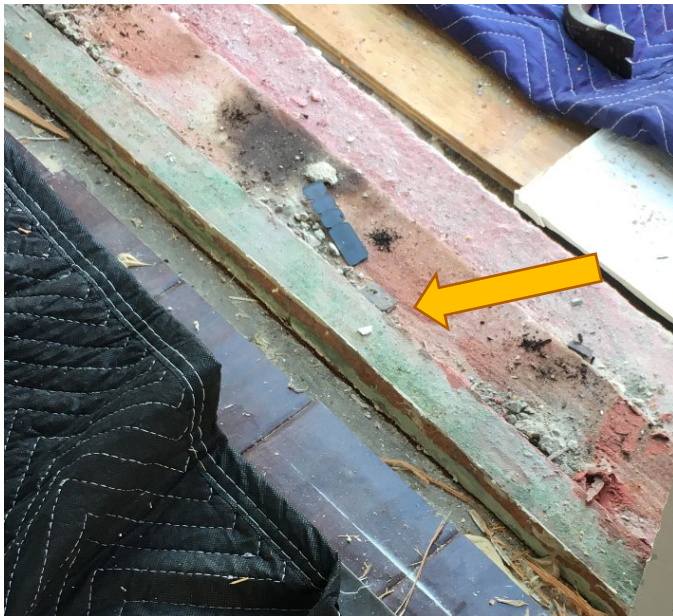
- No full sill pan as per Loewen and Florida code install instructions.
- No evidence of silicone or sealant over screws that run directly through the unit into concrete.

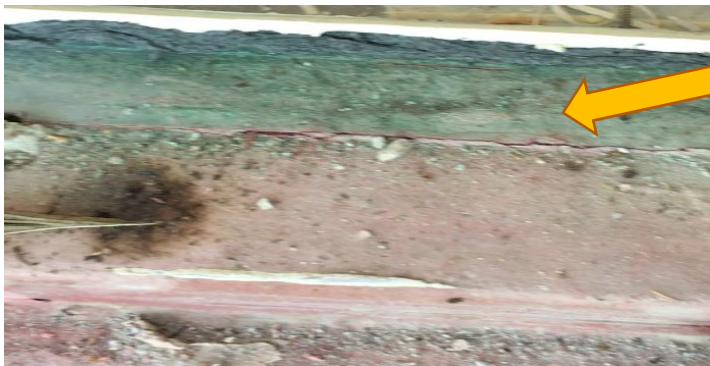
- In lieu of a full sill pan between the window unit and the concrete, a narrow 1" copper strip was discovered positioned towards the interior side of the unit – not in compliance with Loewen install instructions

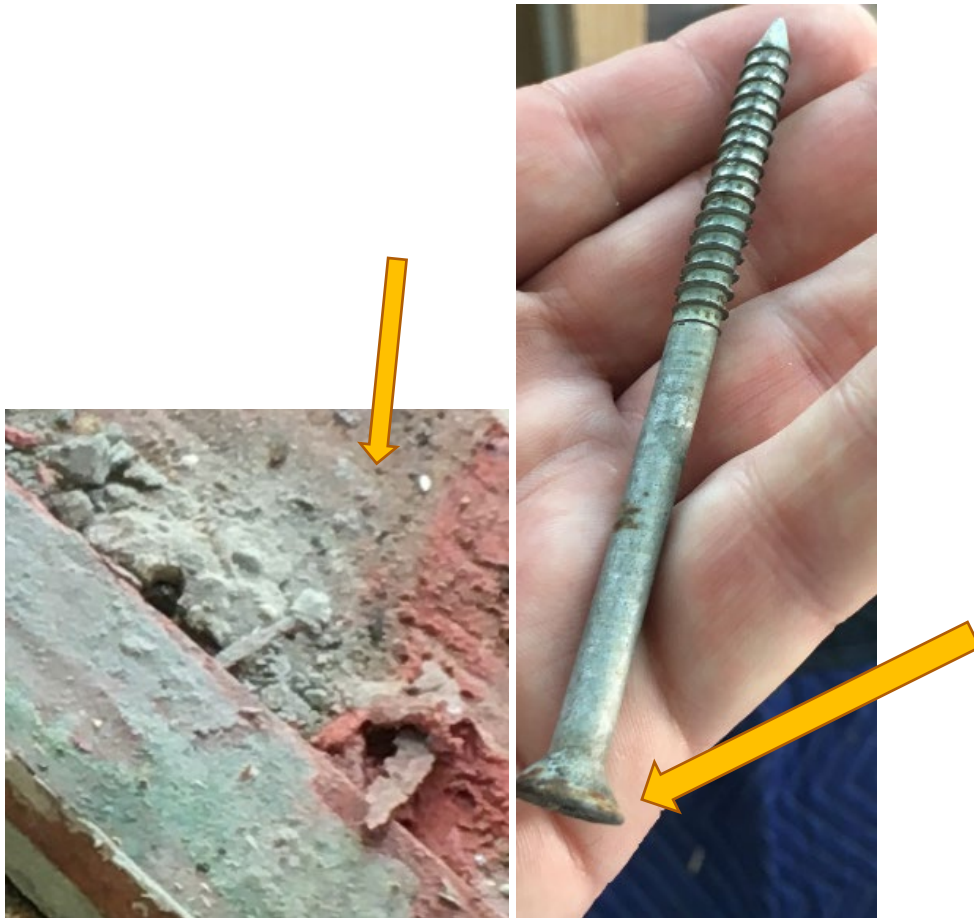
- Sill secured by 2 large screws through jamb into concrete, no buck. No silicone on screws into jamb or concrete (porous).

- Spots on concrete (no buck) shows through to bare concrete – Prosoco not uniformly and adequately applied.

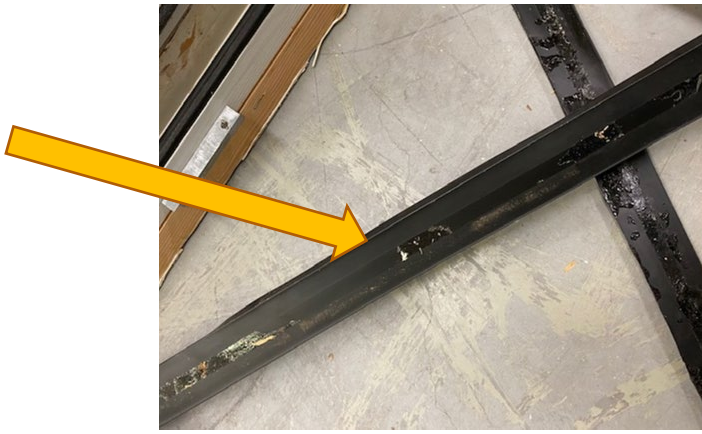
- No Weather stripping on the bottom sash of NNN/OOO/PPP.
- OOO/PPP – no spacer blocks present.
- OOO was installed upside down.

- Jamb liners for service procedure on OOO/PPP was not sealed with sealant (both sides of tape).

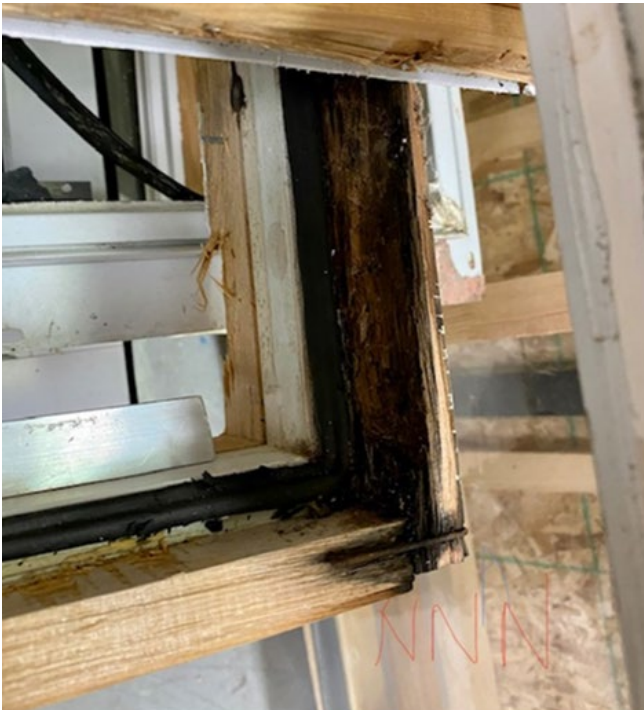
- NNN was not replaced with a new sash as provided by Loewen on service order. Old sash was reinstalled per BCB document from June 26, 2020.

- NNN did not have jamb liners as part of Loewen Service procedure.
- Gaps at mull covers on OOO/PPP are separated and not sealed (these units were mullled on site). All mulls were not sealed.

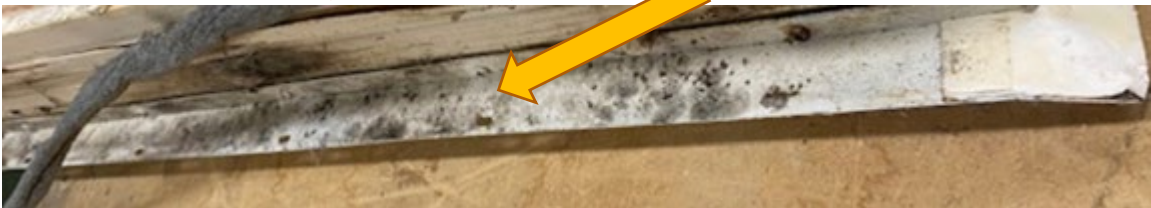
- No sealant behind nail fins (NNN,OOO,PPP).

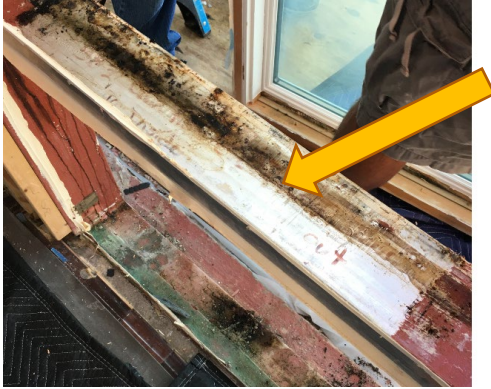
- Vertical tube mulls with 2X applied for bucking.
- Horizontal tube mulls - no bucking. Horizontal tube mulls show red waterproofing on ends only, middle bare.

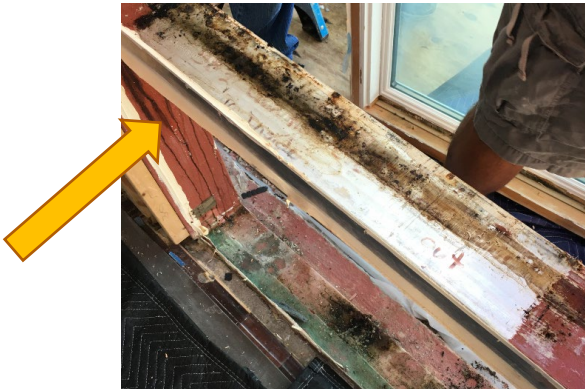
- Middle buck shows signs of water infiltration on sides.

- Middle tube leaking water from inside tube. CFP used an air compressor to dry interior of tube.
- Lack of waterproofing or sealant on horizontal tube allowed water to follow the screws in the horizontal tube filling it with water.
- No shims, no sealant or Prosoco on horizontal mull.

- All screw holes on the top and bottom sides of the horizontal tube mulls were sealed with Pink Joint & Seam Seal (Prosoco Product).
- Red Prosoco applied to entire perimeter bucking and sill before install. Also, waterproofed all vertical and horizontal aluminum tubes with Red Fast Flash (Prosoco Product).

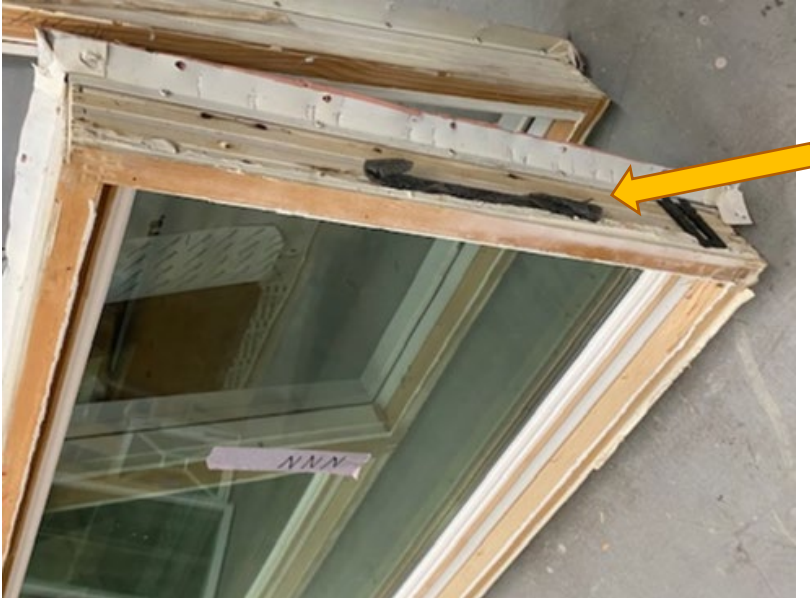
- Outside (NNN and PPP units) showed no evidence of rot.

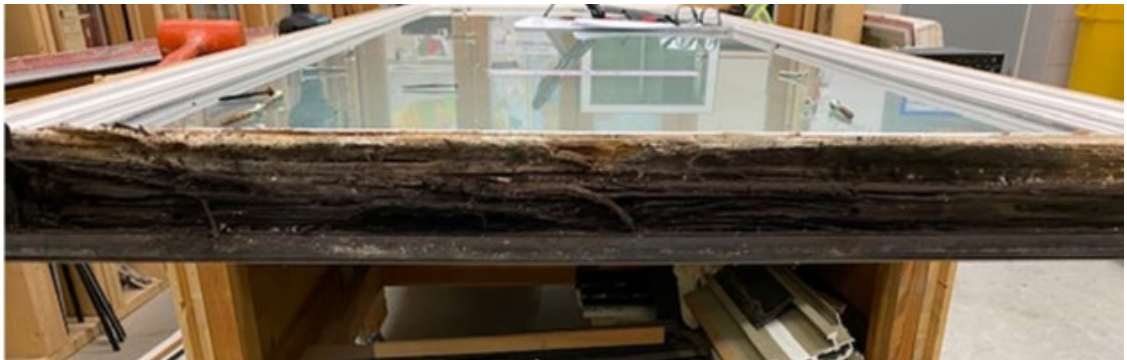
- Middle (OOO) showing signs of water intrusion at sash and frame.

- Deterioration of the bottom of window sash due to previously noted deficiencies in sealant and installation procedures, enabling penetration of water. Water exposure exacerbated by placement of the Awning over the door adjacent to unit, as noted above.
