BCB – Sullivan’s Residence, 620 Admiralty Parade, Port Royal Naples, Florida

UNIT VV – SECOND FLOOR, SOUTH REAR ELEVATION

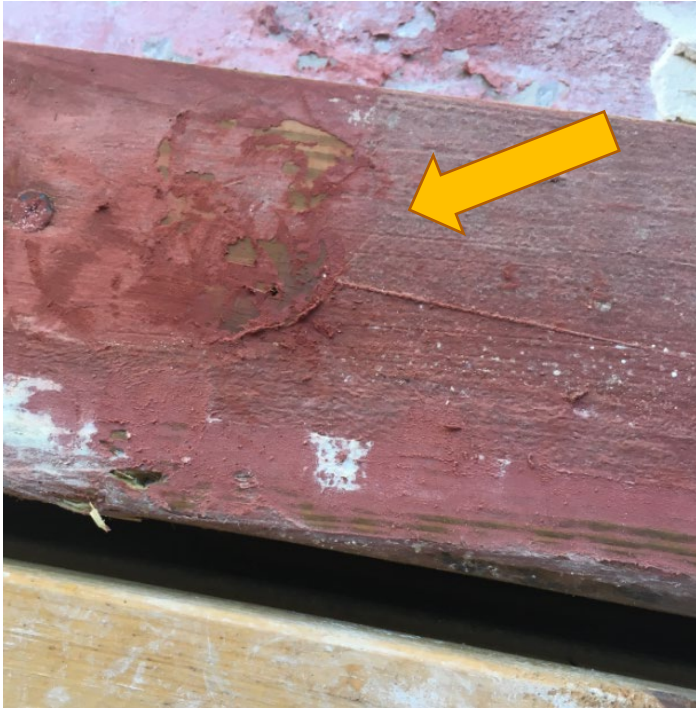
- Spots on pressure treated buck shows through to bare wood – Prosoco not uniformly and adequately applied.

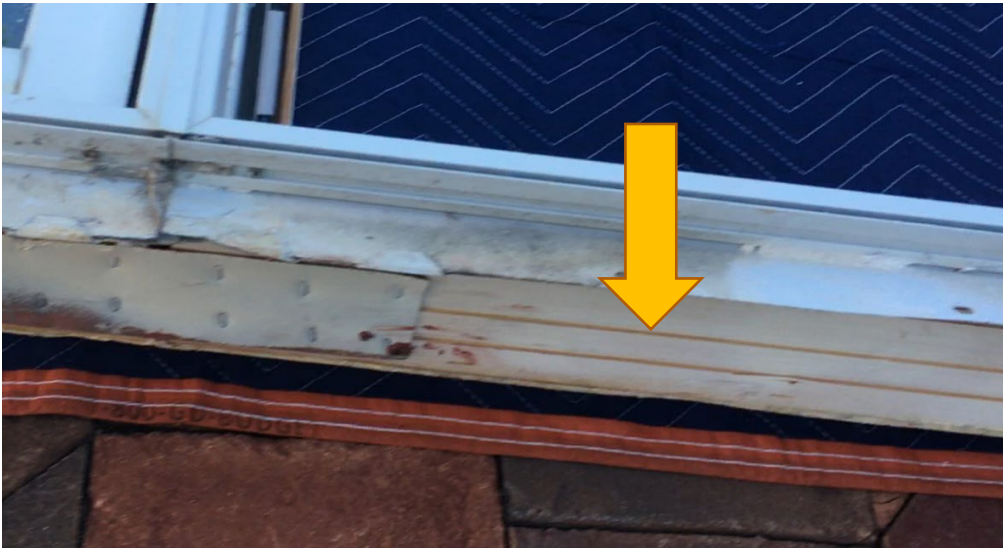
- White Caulking applied to perimeter of interior Window, all 4 sides.

- No rot found on perimeter of frame.

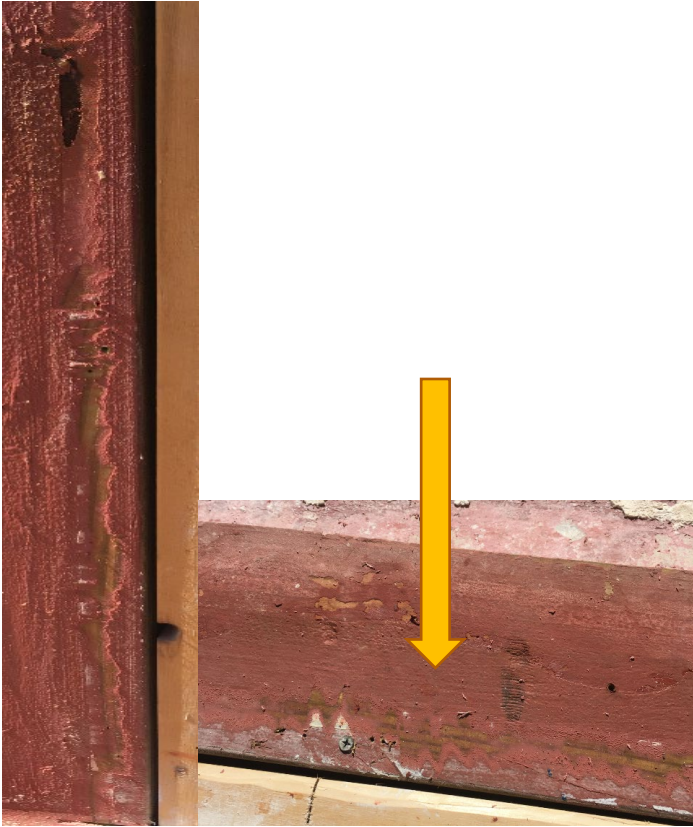
- Spots on pressure treated buck shows through to bare wood – Prosoco not uniformly and adequately applied.

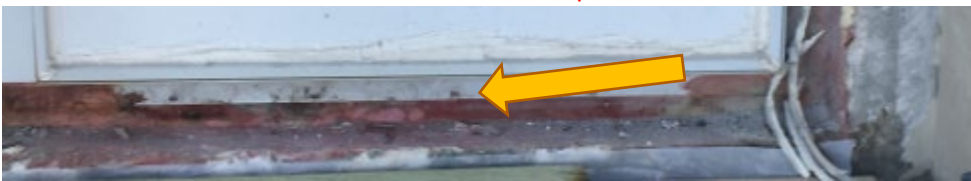
- Three top windows - entire nail fin screwed completely around perimeter.
- Bottom nail fin not screwed to buck via Loewen pre-drilled holes.

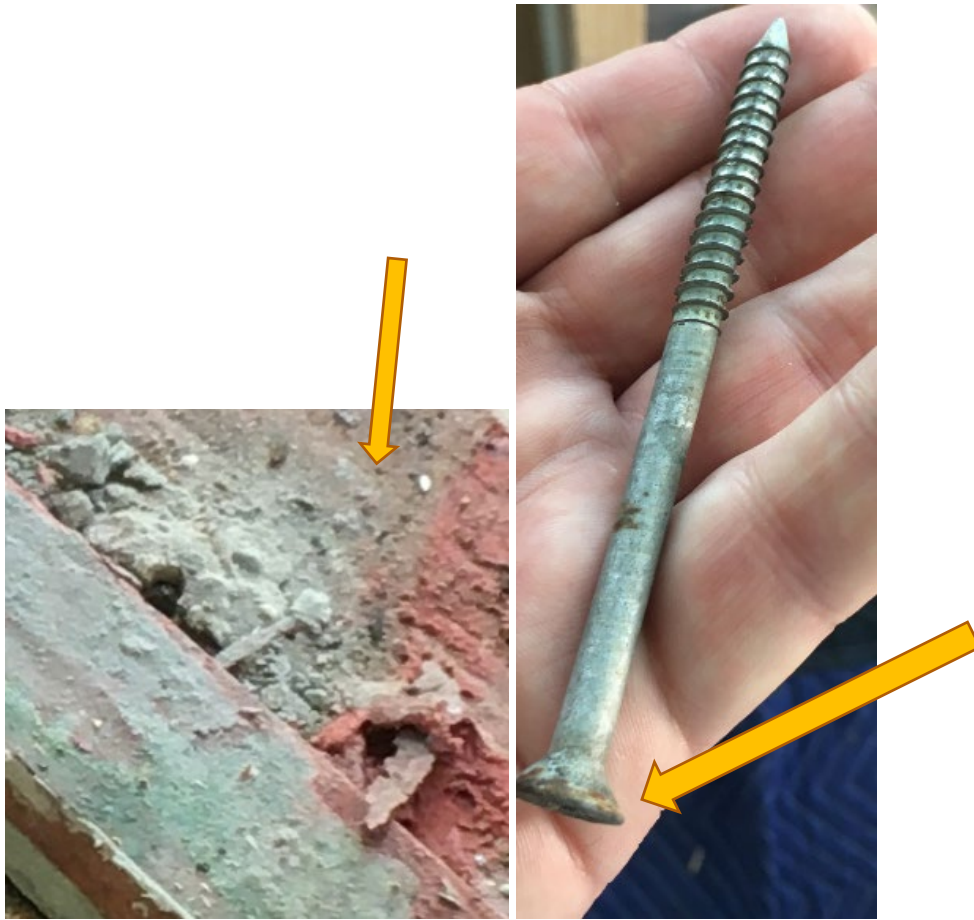
- Sill secured by 2 large screws through jamb into concrete, no buck. No silicone on screws into jamb or concrete (porous).

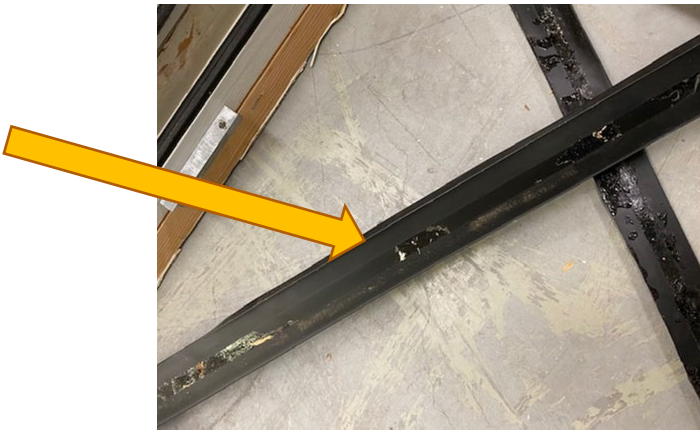
- No Weather stripping on the bottom sash of NNN/OOO/PPP.
- OOO/PPP – no spacer blocks present.
- OOO was installed upside down.

- Jamb liners for service procedure on OOO/PPP was not sealed with sealant (both sides of tape).

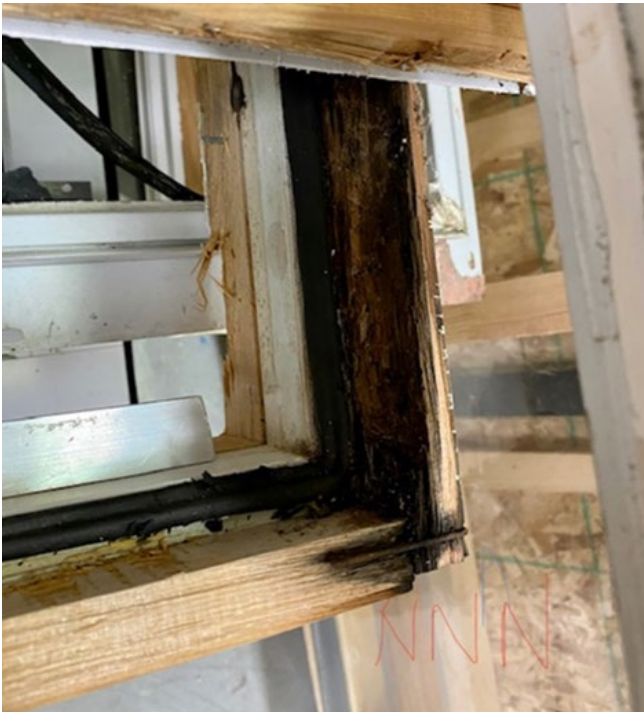
- NNN was not replaced with a new sash as provided by Loewen on service order. Old sash was reinstalled per BCB document from June 26, 2020.

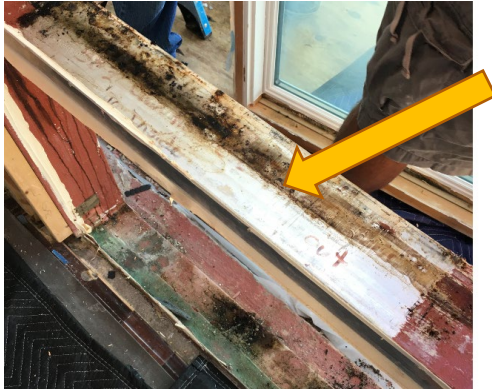
- Vertical tube mulls with 2X applied for bucking.
- Horizontal tube mulls - no bucking. Horizontal tube mulls show red waterproofing on ends only, middle bare.

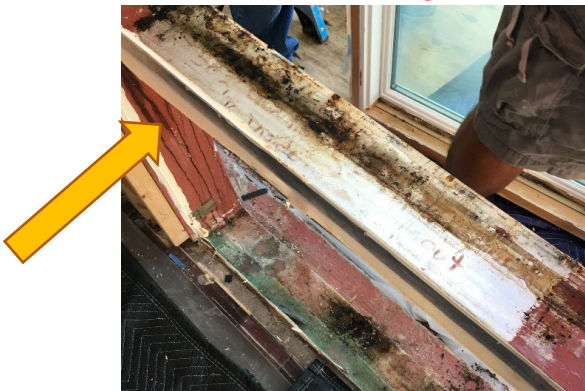
- Middle buck shows signs of water infiltration on sides.

- Middle tube leaking water from inside tube. CFP used an air compressor to dry interior of tube.
- Lack of waterproofing or sealant on horizontal tube allowed water to follow the screws in the horizontal tube filling it with water.
- No shims, no sealant or Prosoco on horizontal mull.

- All screw holes on the top and bottom sides of the horizontal tube mulls were sealed with Pink Joint & Seam Seal (Prosoco Product).
- Red Prosoco applied to entire perimeter bucking and sill before install. Also, waterproofed all vertical and horizontal aluminum tubes with Red Fast Flash (Prosoco Product).
