Harold Robair
BCB Homes
3696 Enterprise Avenue
Naples, FL 34104
8/13/19

BCB Homes, at your request, has performed a window and door inspection at your home in Naples. The goal was to determine if the condition that we found at bedroom No. 6 (guest house), on 7/18/19, which was wood rot in the window frame, was an isolated issue or systemic.

Job #: 39231 39231 Sullivan 2019 Loewen Windows
620 Admiralty Parade West
Naples, Florida 34102

Sullivan Loewen Window Inspection

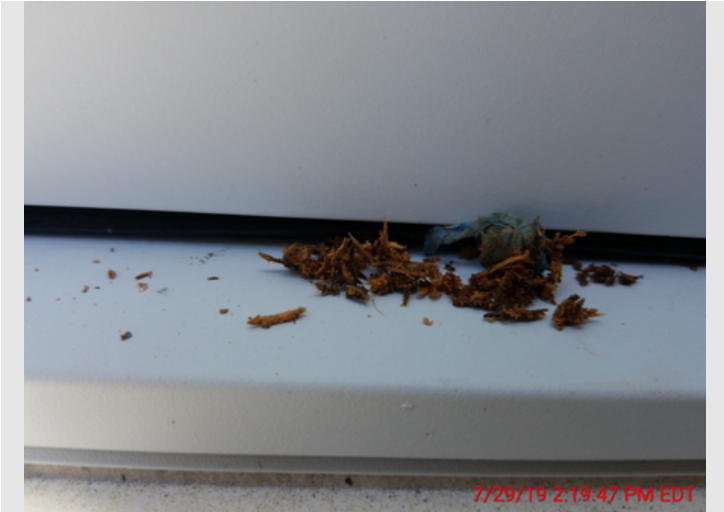
Window "C" fixed (two car garage), close up photo.

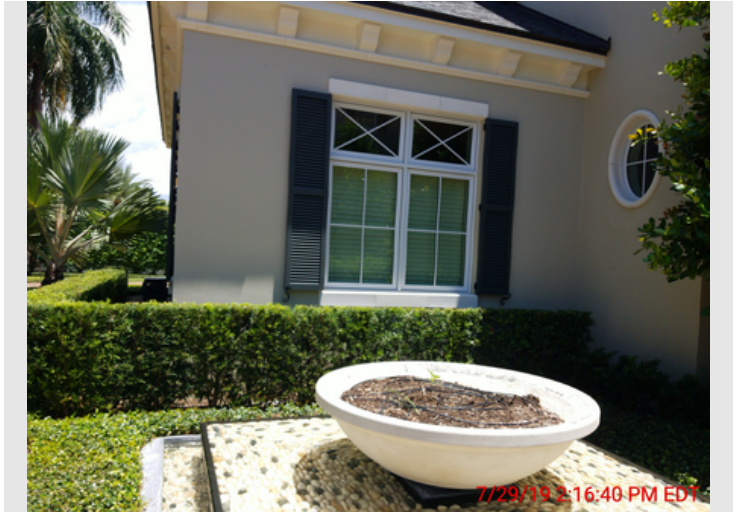
Window "C" fixed (2 Car Garage), right sash Bottom frame is rotted, see close up photo.

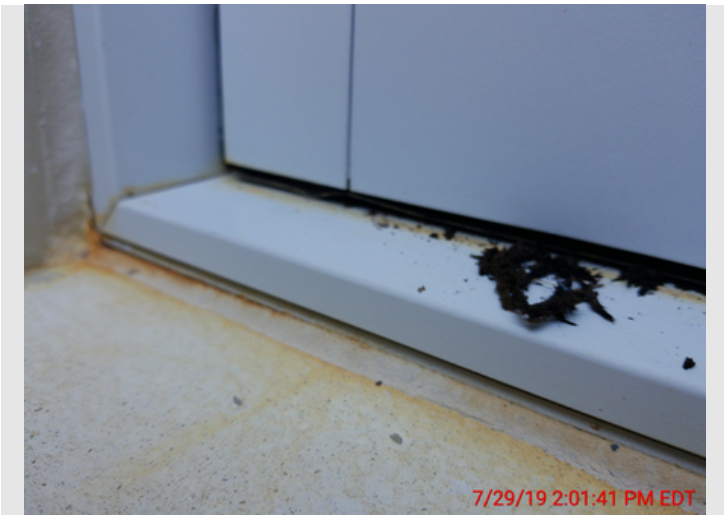
Window "VVV" fixed (BNK Rm), close up photo.

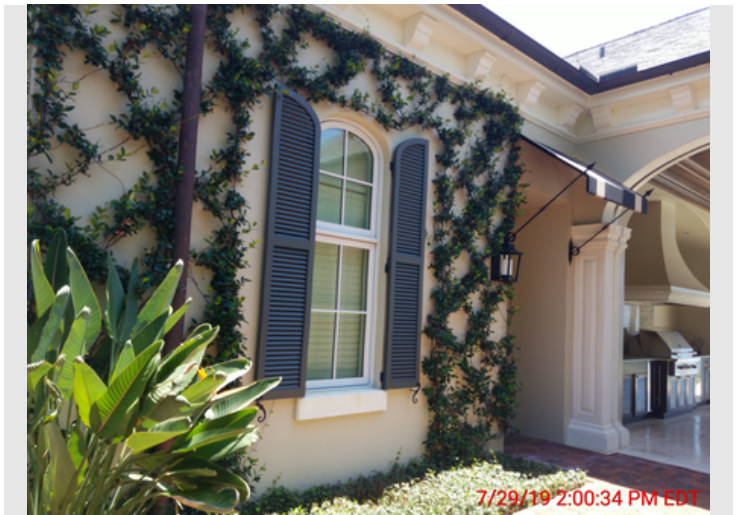
Window "VVV" fixed (BNK Rm), Bottom frame is rotted, see close up photo.

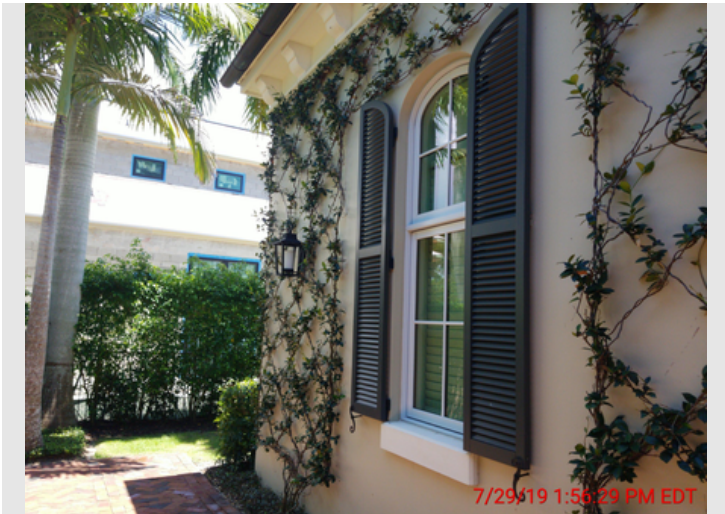
Window "UUU" fixed (BNK Rm), no issues found.

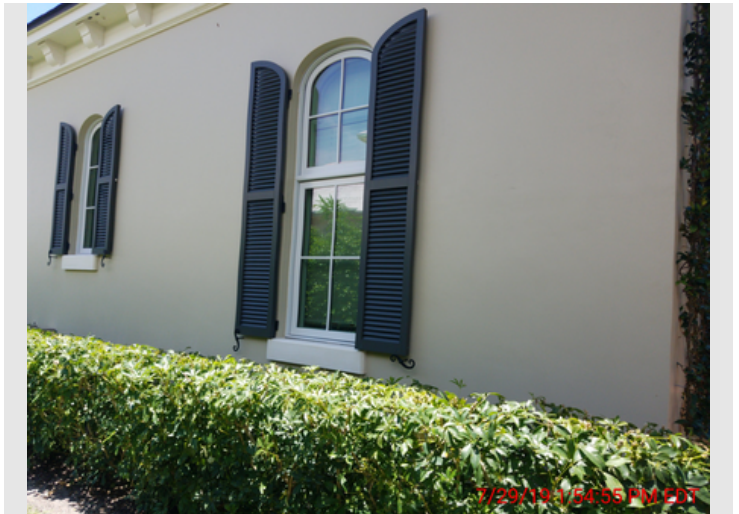
Window "TTT" caseman (BNK Rm), missing exterior caulk bead at bottom frame to precast. No rotted issues found.

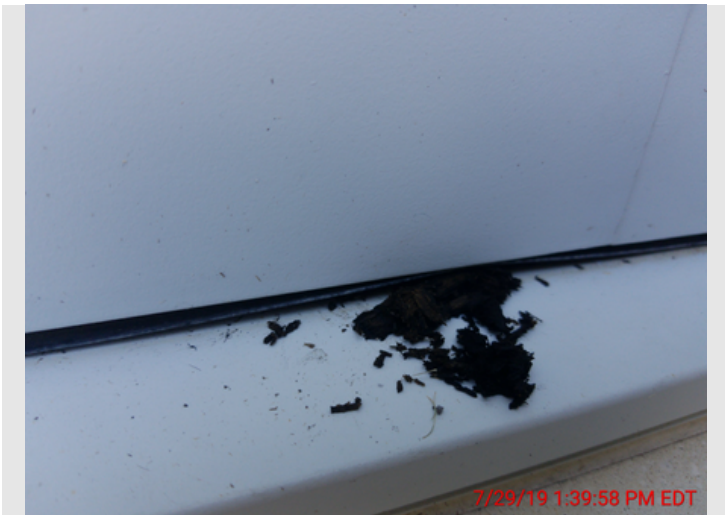
Window "SSS" fixed (Guest Bath), close up photo.

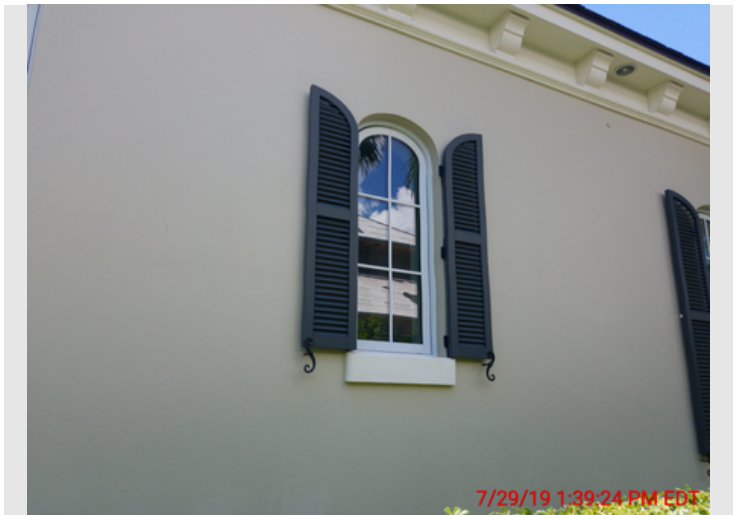
Window "SSS" fixed (Guest Bath), Bottom frame is rotted, see close up photo.

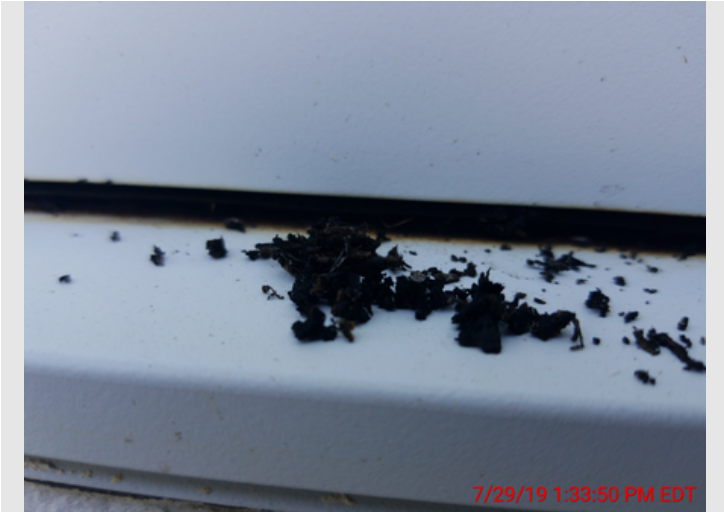
Window "RRR" fixed (Guest Living), close up photo.

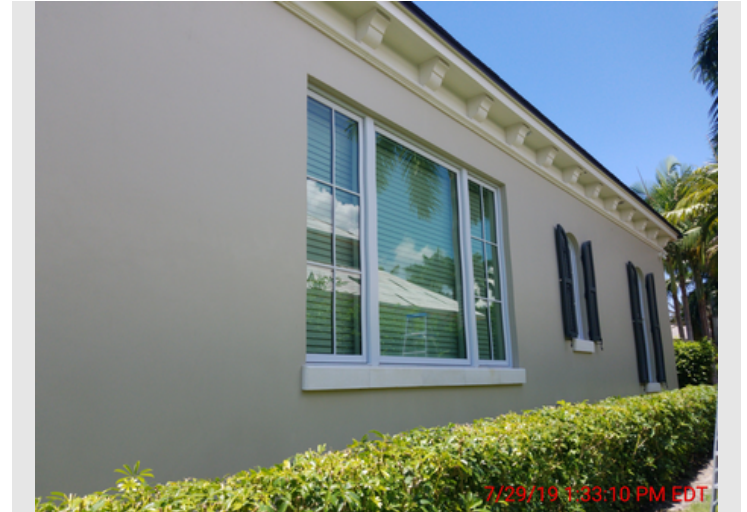
Window "RRR" fixed (Guest Living), right sash bottom frame is rotted, see close up photo.

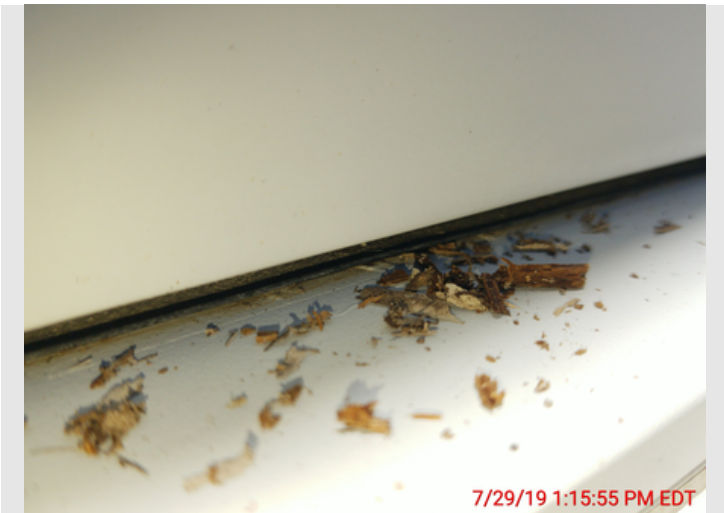
Window "WWW" fixed (Pool Bath), close up photo.

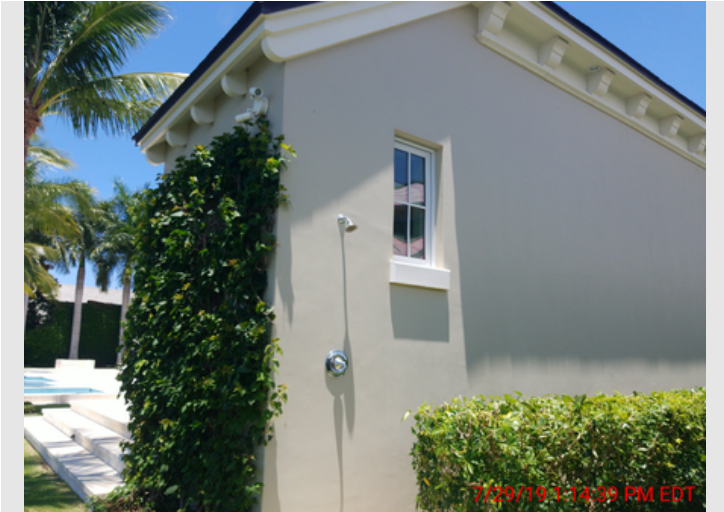
Window "WWW" fixed (Pool Bath), close up photo.

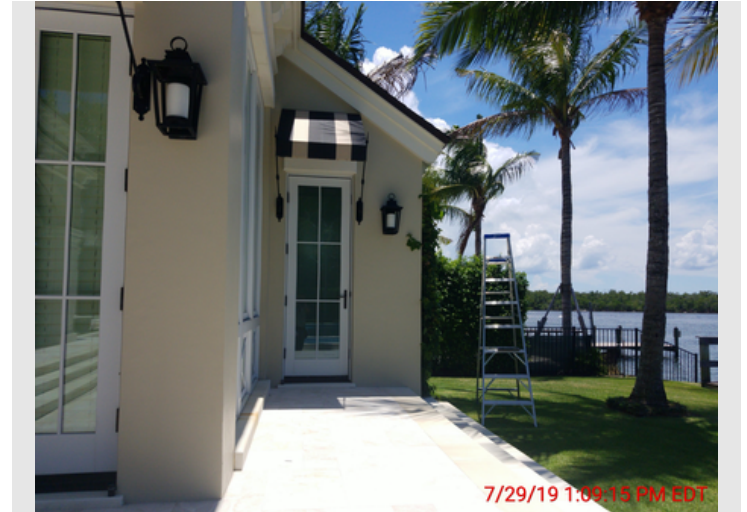
Door "26" (Pool Bath), no issues found.

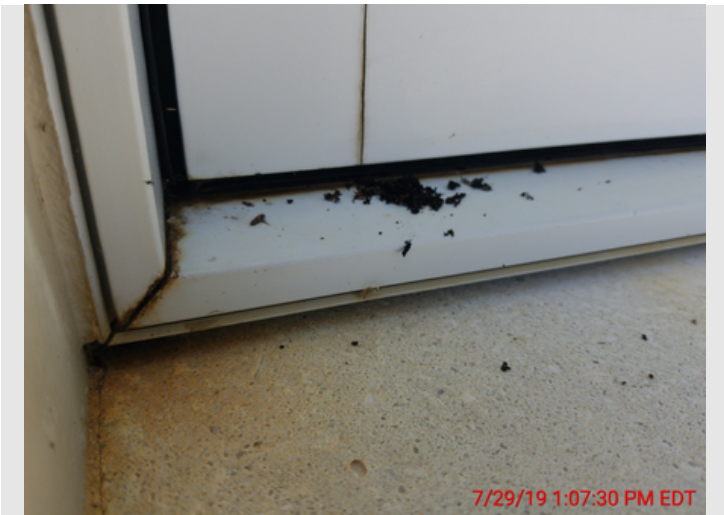
Window "NNN" fixed (Bedroom #6), close up photo.

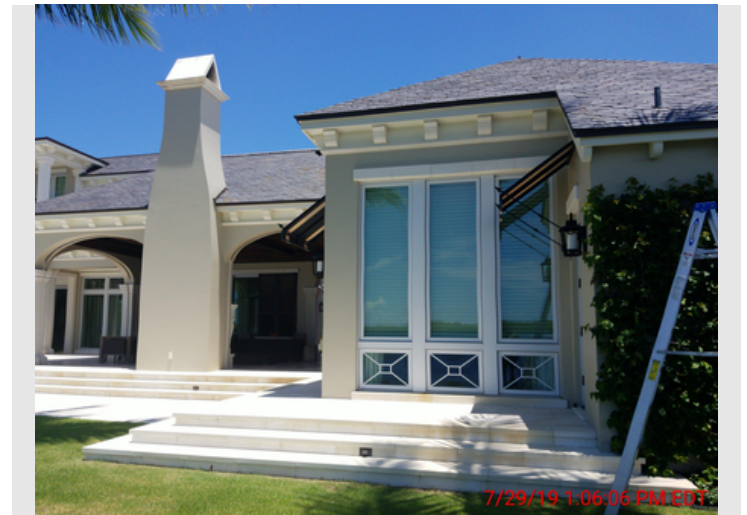
Window "NNN" fixed (Bedroom #6), Bottom frame is rotted, see close up photo.

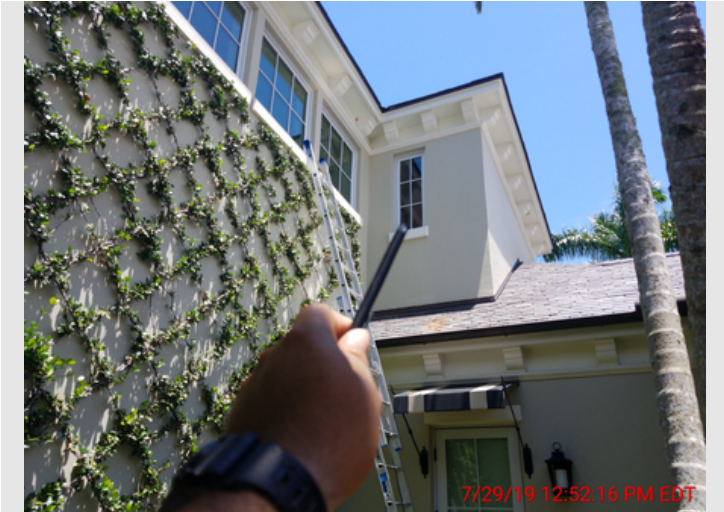
Window "MMM" fixed (Bathroom#5), no issues found.

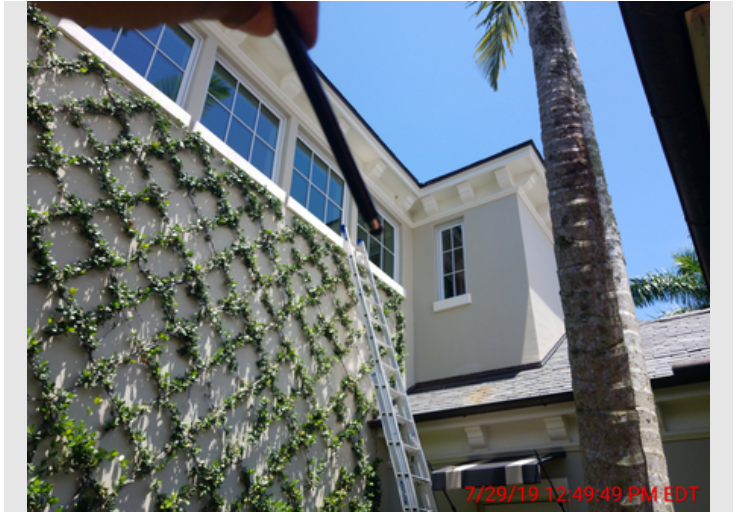
Window "YYY" fixed (East stairway), no issues found.

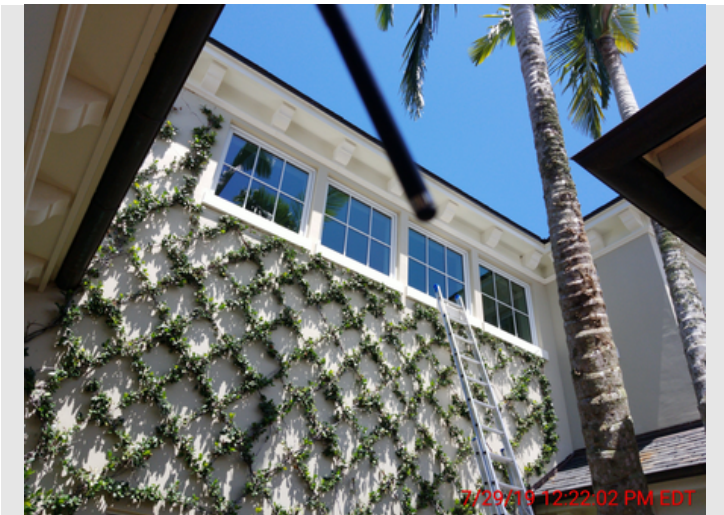
Window "LLL" fixed (East Stairway), Bottom frame starting to show rot. See close up photo.

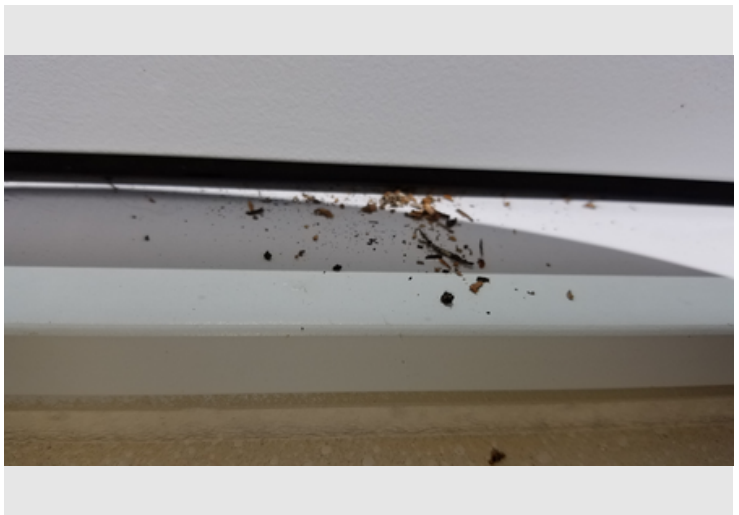
Window "LL" fixed (East Stairway), close up photo.

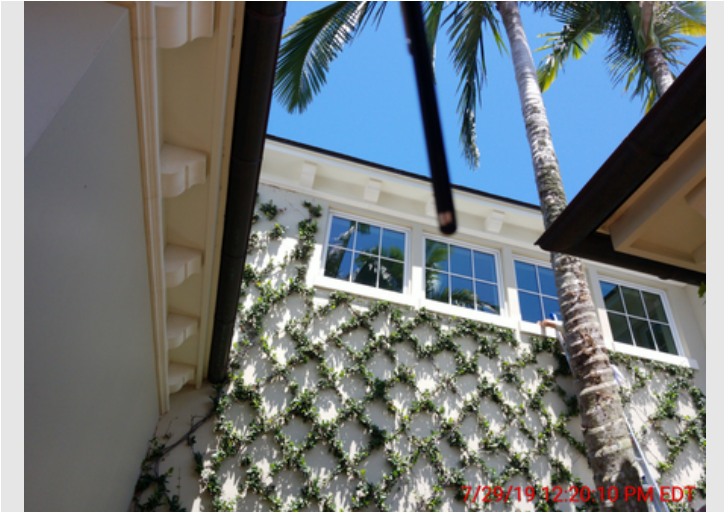
Window "KKK" fixed (East Stairway), No issues found.

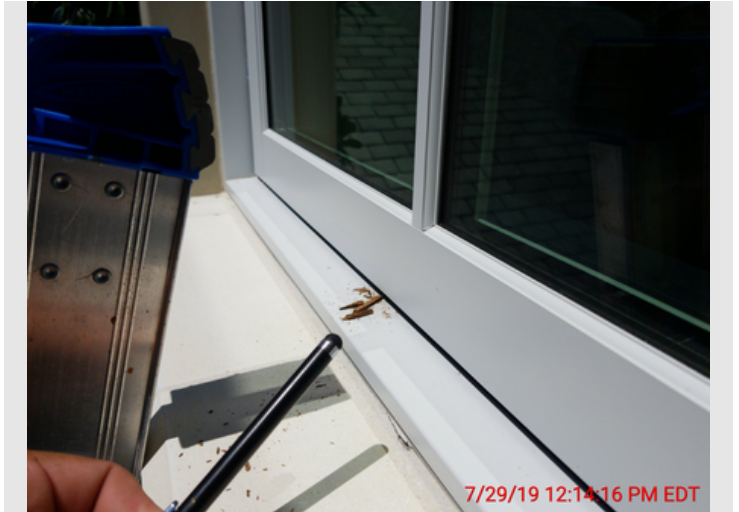
Window "HHH" fixed (East Stairway), Close up photo.

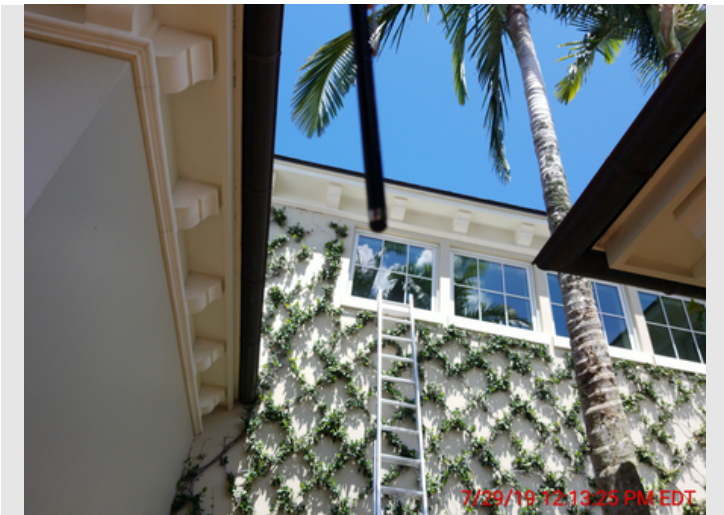
Window "HHH" fixed (East Stairway), Bottom frame starting to show rot. See close up photo.

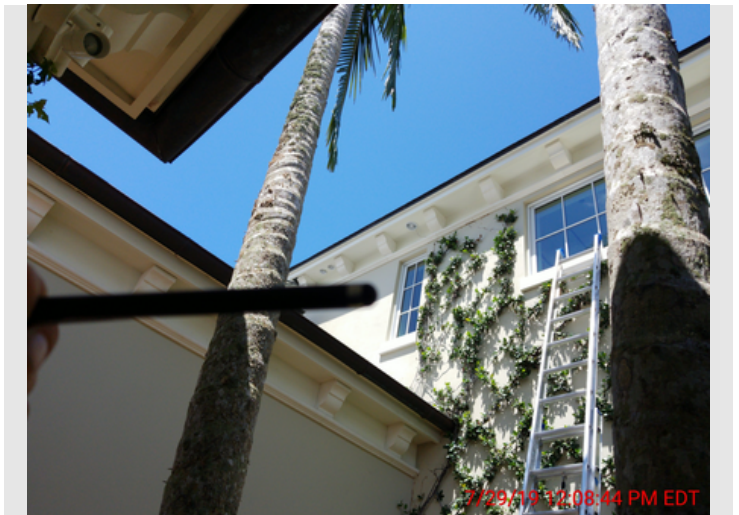
Window "FFF" fixed (Bathroom #3), No issues found.

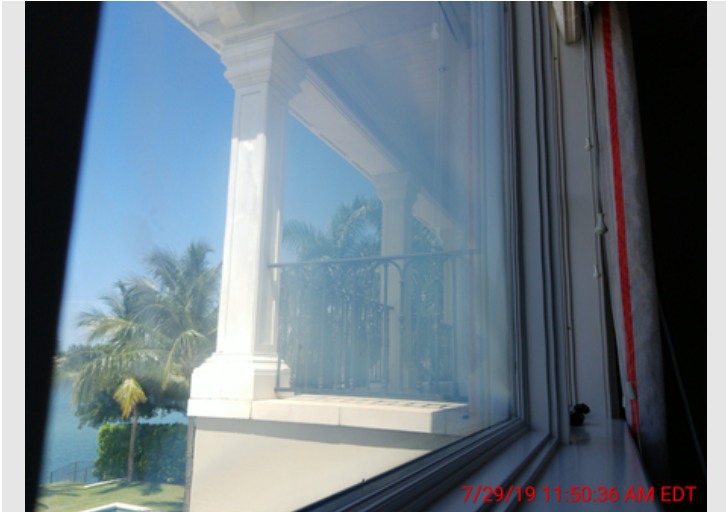
Window "EEE" fixed panel (Bedroom #3), close up photo

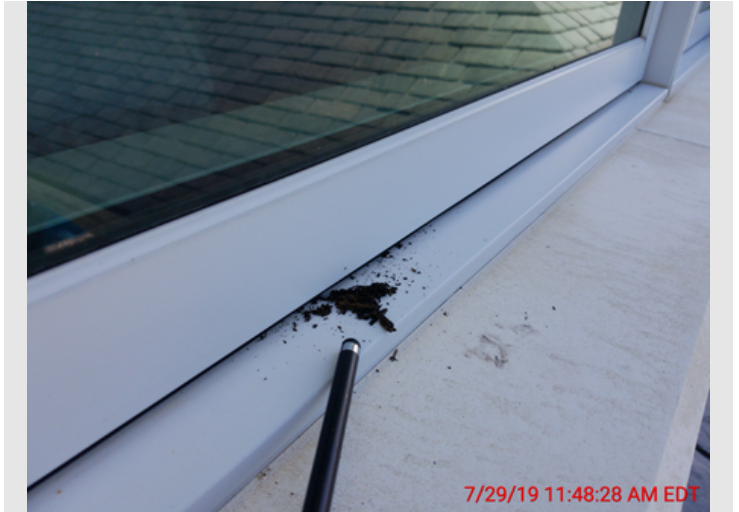
Window "EEE" casement/fixed (Bedroom #3), Close up photo 1 of 2.

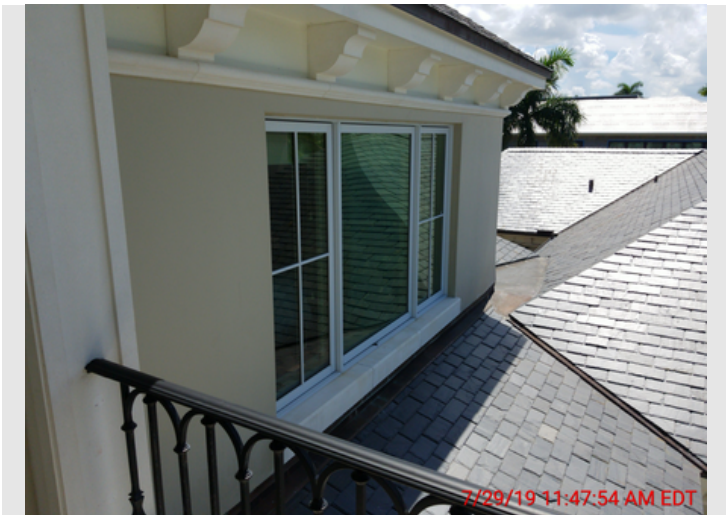
Window "EEE" casement/fixed (Bedroom #3), Fixed panel bottom frame is rotted and glass is delaminated. See close up photos.

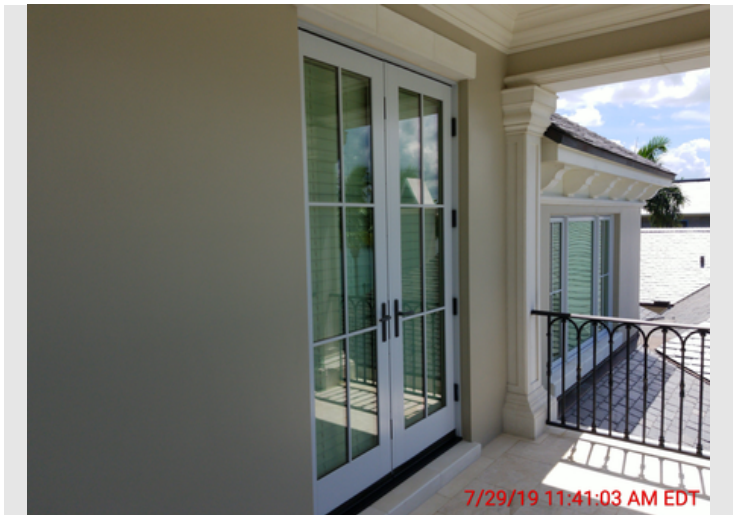
Door #61 (Master Suite), No issues found.

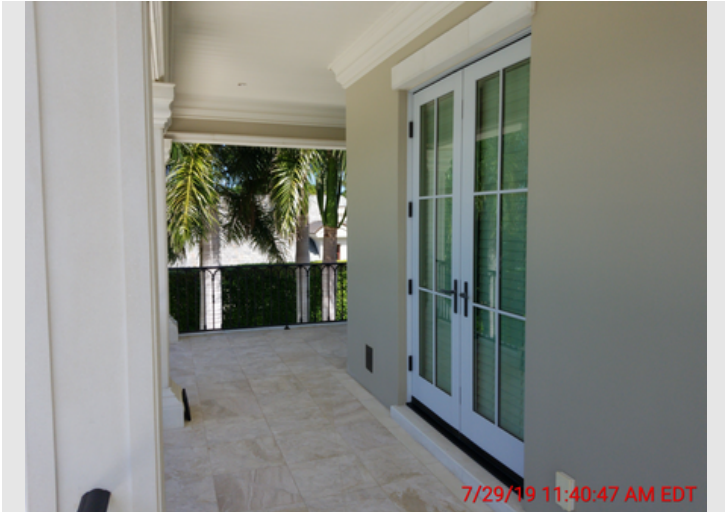
Door #60 (Master Suite), No issues found.

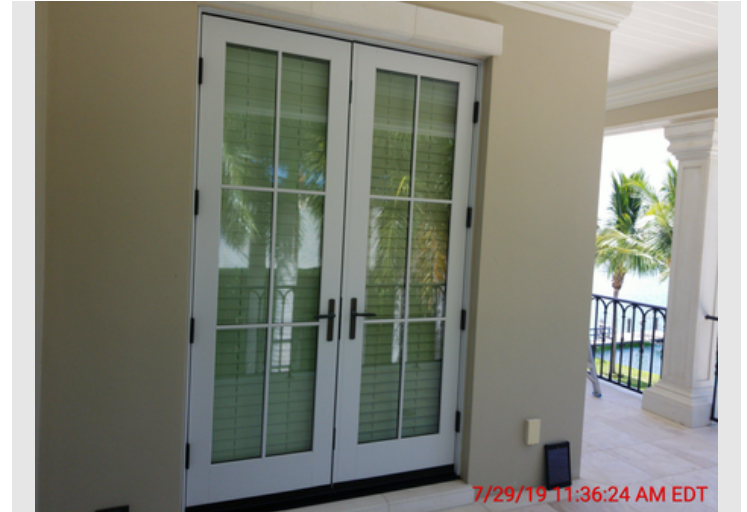
Door #59 (Master Suite), No issues found.

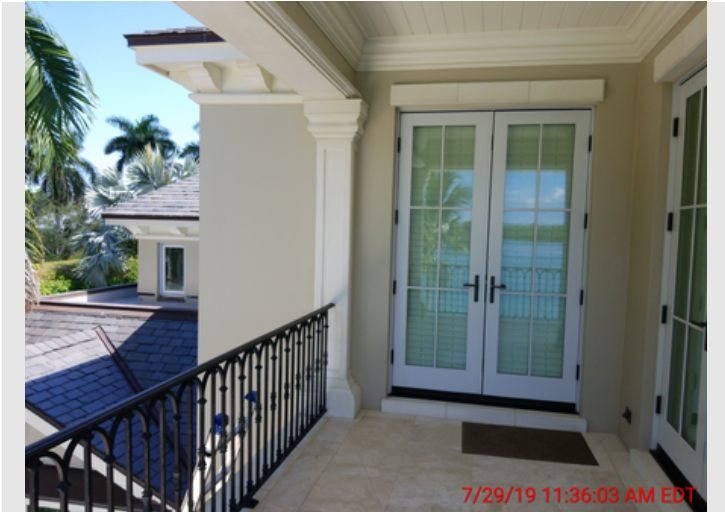
Door #56 (2nd Floor Sitting), No issues found.

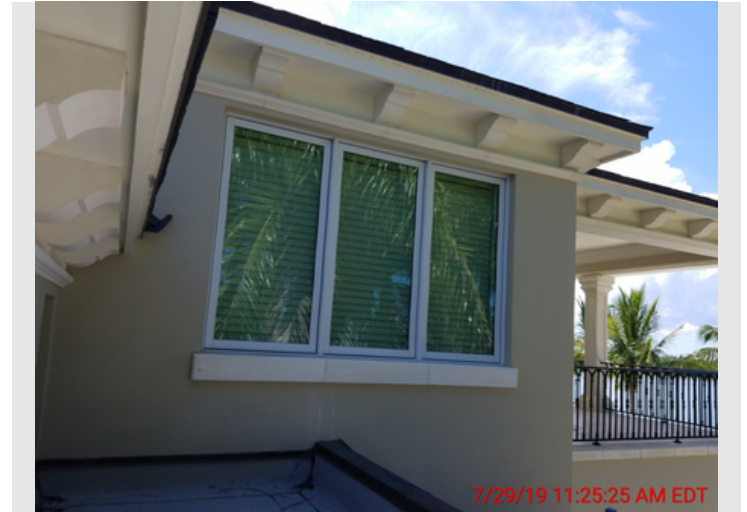
Window "VV" fixed (2nd Floor Sitting), No issues found.

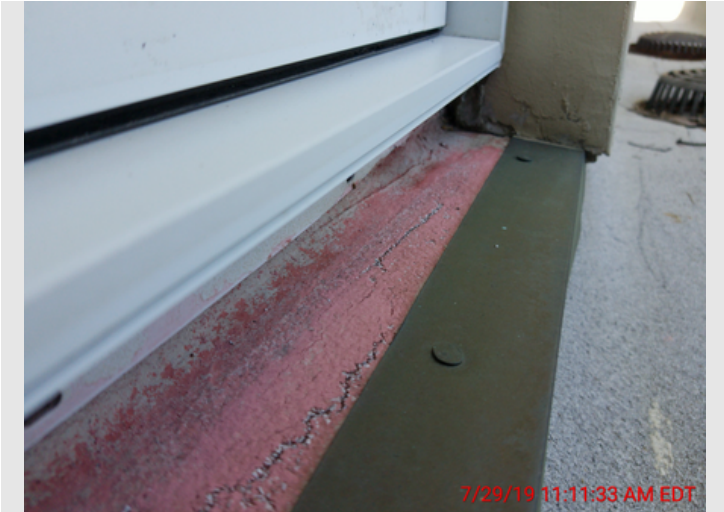
GENERAL NOTE; Windows "HH thru TT" fixed (Open to Study), Close up photo 2 of 2.

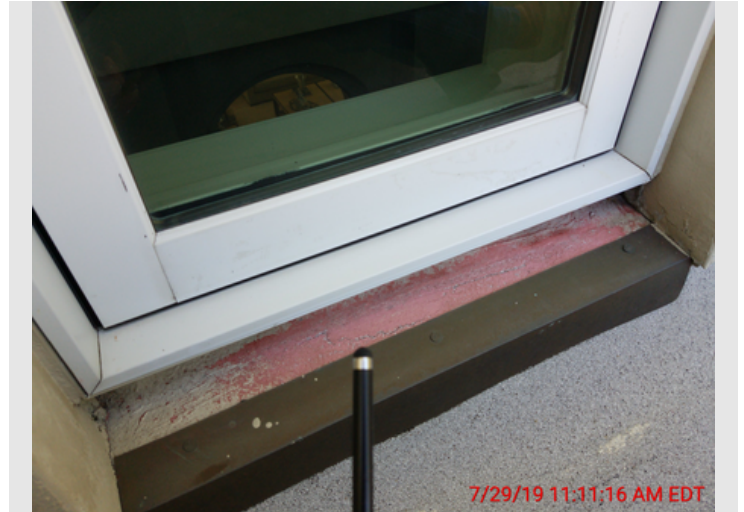
GENERAL NOTE; Windows "HH thru TT" fixed (Open to Study), Close up photo 1 of 2.

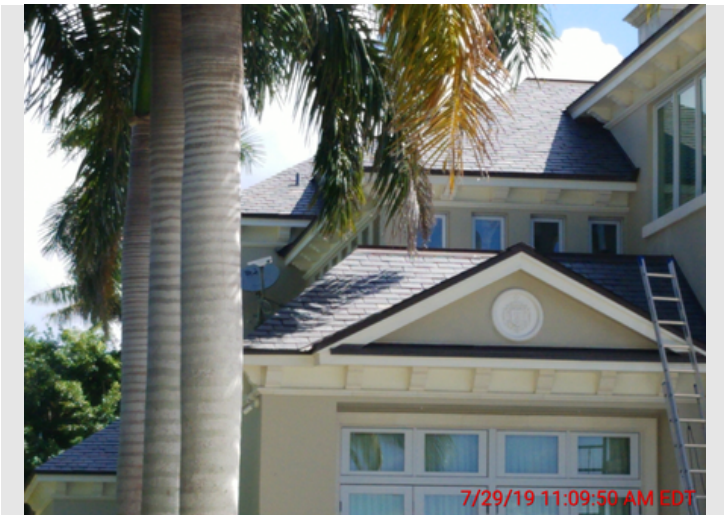
GENERAL NOTE; Windows "HH thru TT" fixed (Open to Study), Sill waterproofing exposed to weather and deterioration, needs to be repaired a...

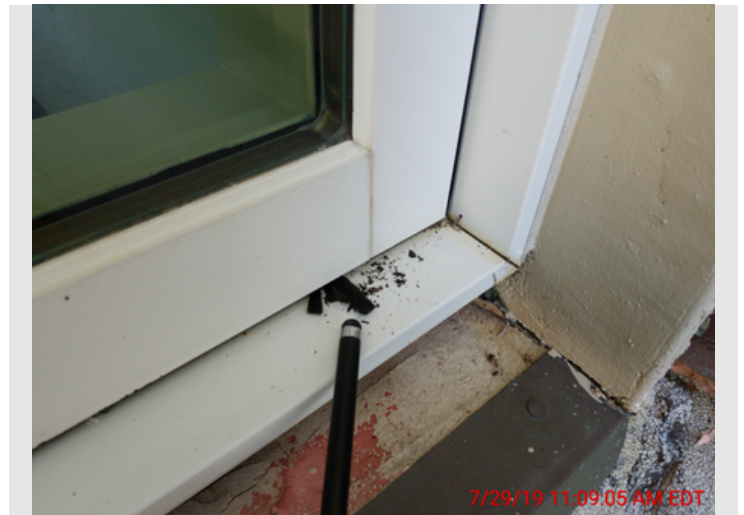
Window "TT" fixed (Open to study), Close up photo.

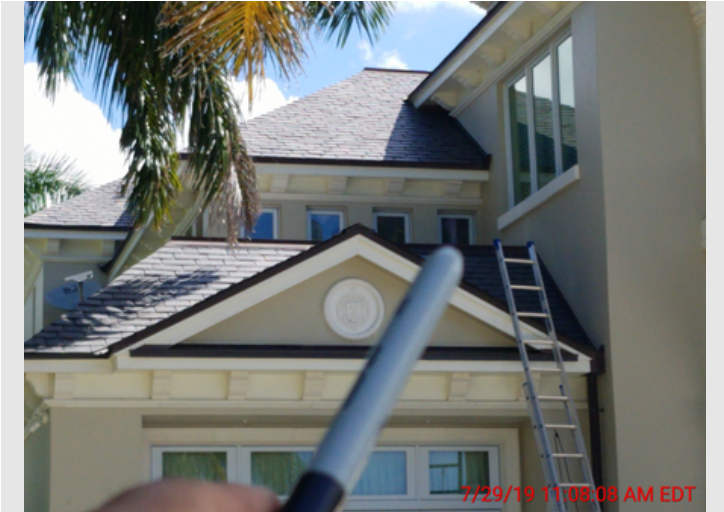
Window "TT" fixed (Open to Study), Bottom frame is rotted, see close up photo.

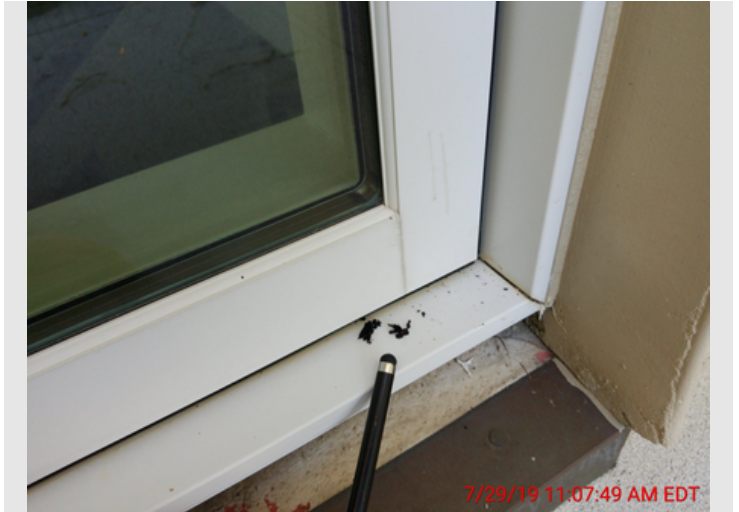
Window "SS" fixed (Open to study), Close up photo.

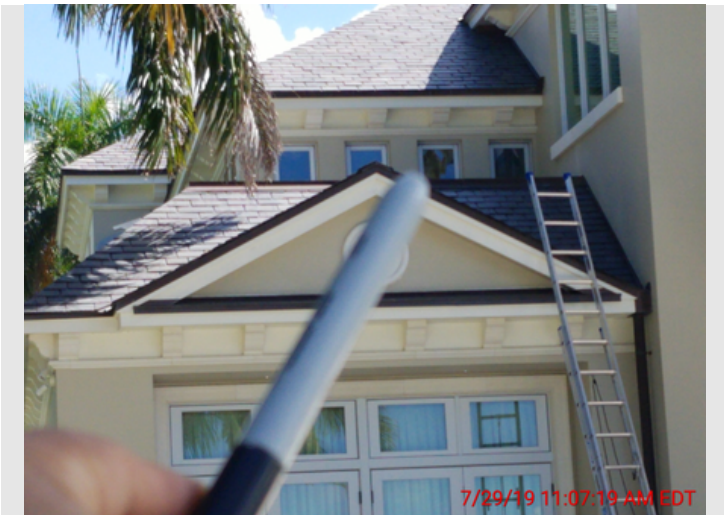
Window "SS" fixed (Open to Study), Bottom frame is rotted, see close up photo.

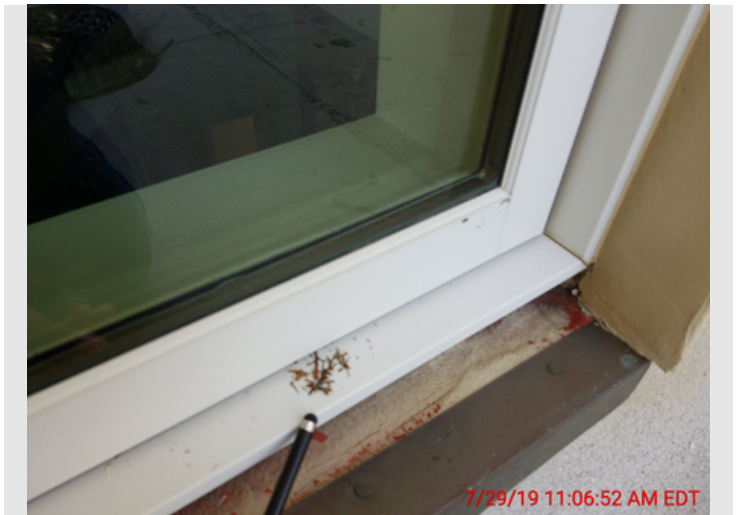
Window "RR" fixed (Open to study), Close up photo.

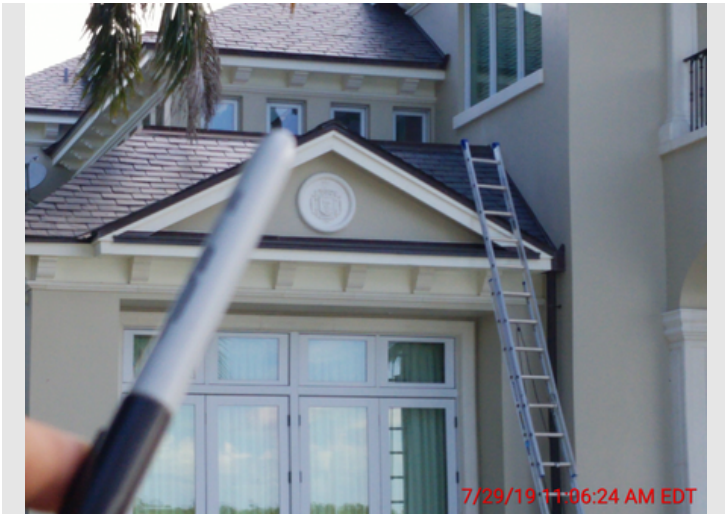
Window "RR" fixed (Open to Study), Bottom frame is rotted, see close up photo.

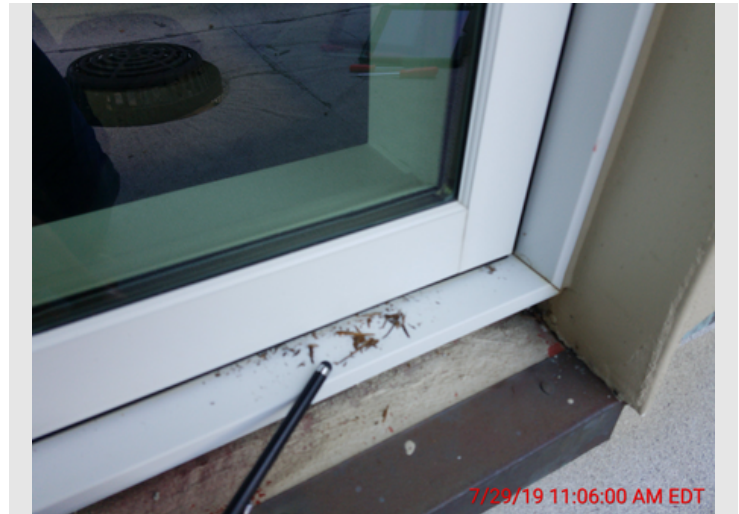
Window "PP" fixed (Open to Study), Close up photo.

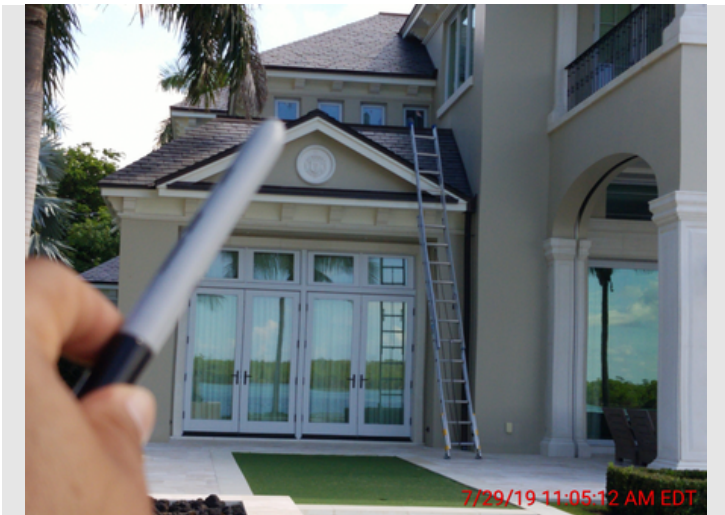
Window "PP" fixed (Open to Study), Bottom frame is rotted, see close up photo.

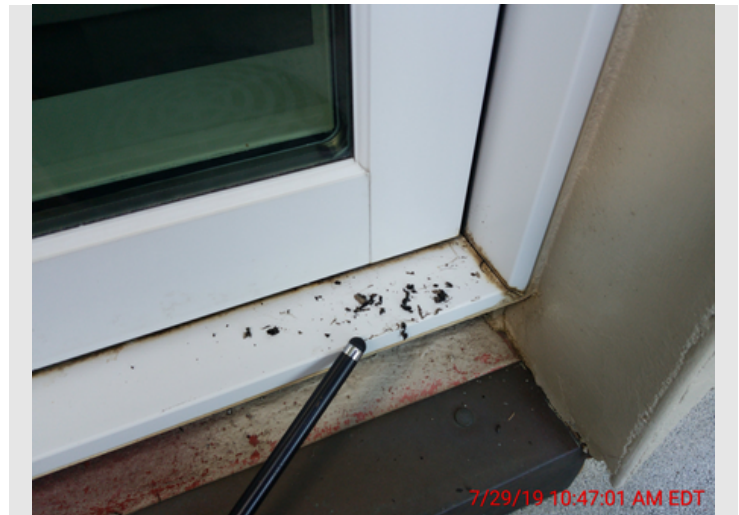
Window "LL" fixed (Open to Study), Close up photo.

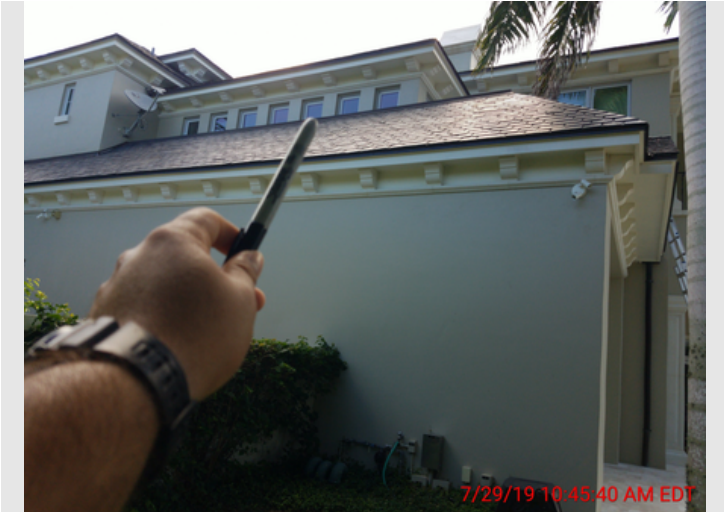
Window "LL" fixed (Open to Study), Bottom frame is rotted, see close up photo.

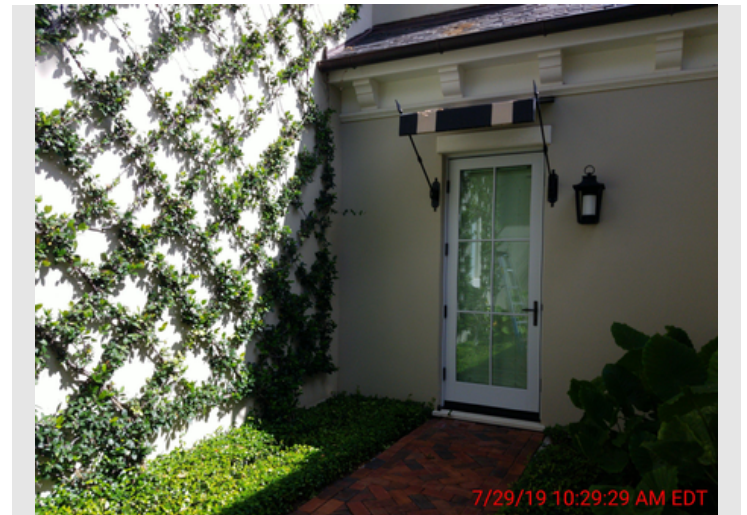
Door #13 (Lndry/Chng's Rm), no issues found.

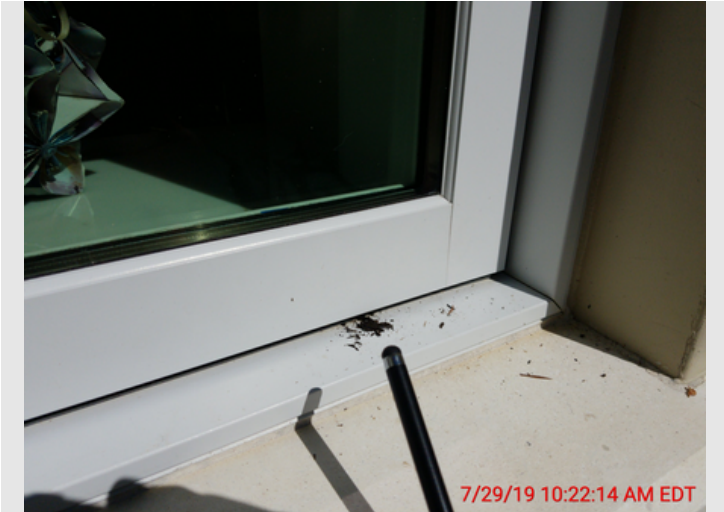
Window "U" fixed (Kitchen), Close up photo.

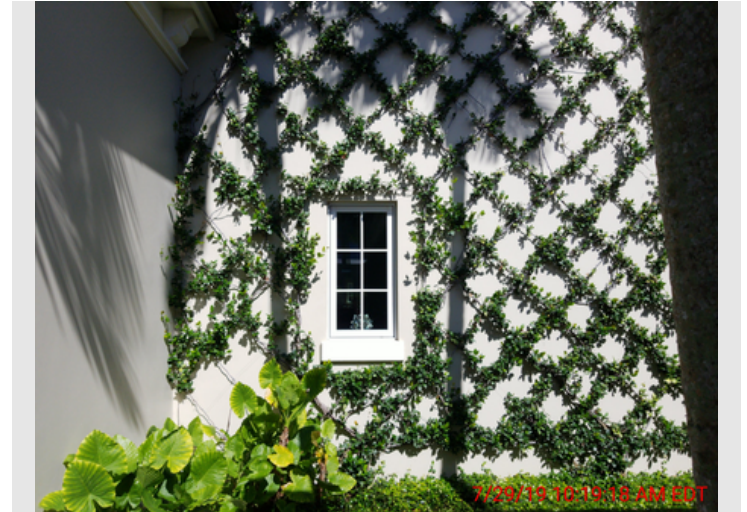
Window "U" fixed (Kitchen), bottom frame starting to show rot. See close up photo.

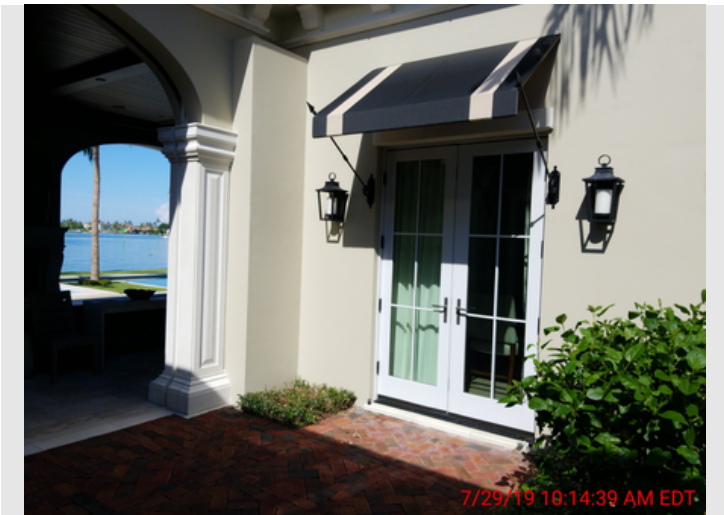
Door #14 (Dining), No issues found.

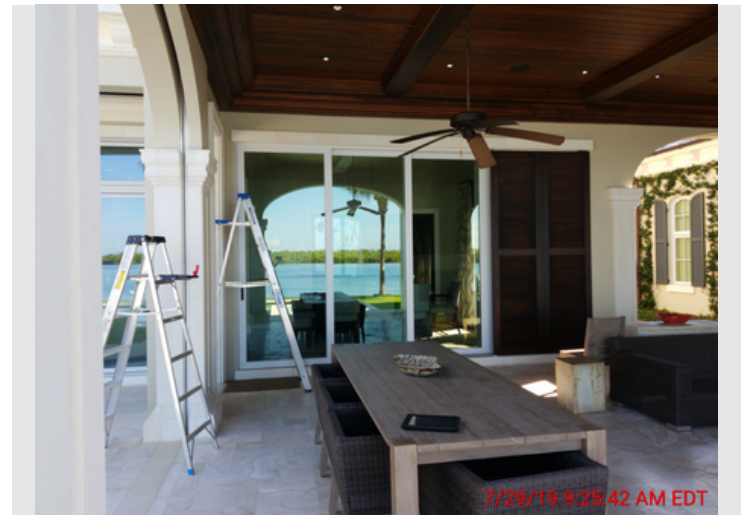
Door #9 (Dining), No issues found.

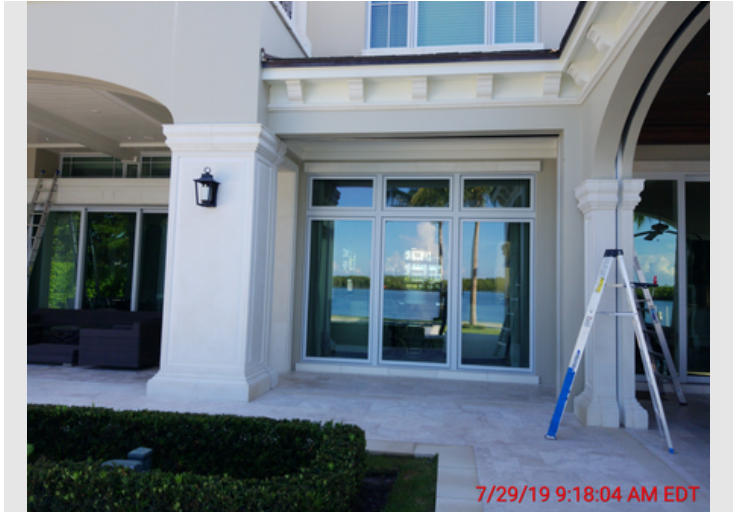
Window "P" fixed (1st Floor Sitting), No issues found.

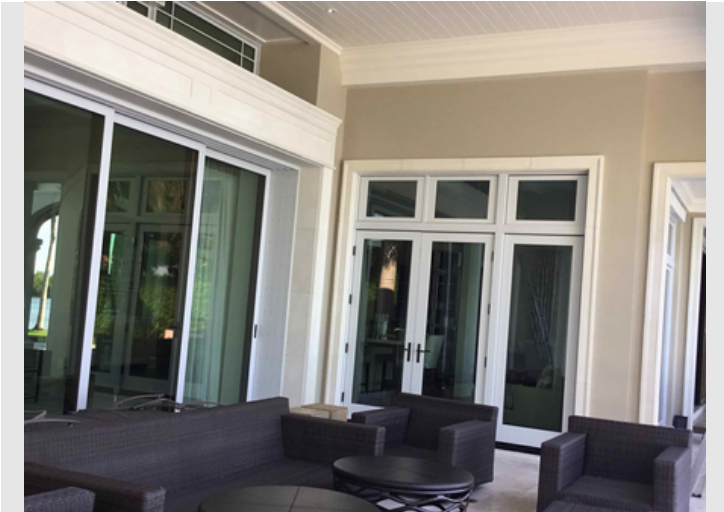
Door #7 (1st Floor Sitting), no issues found.

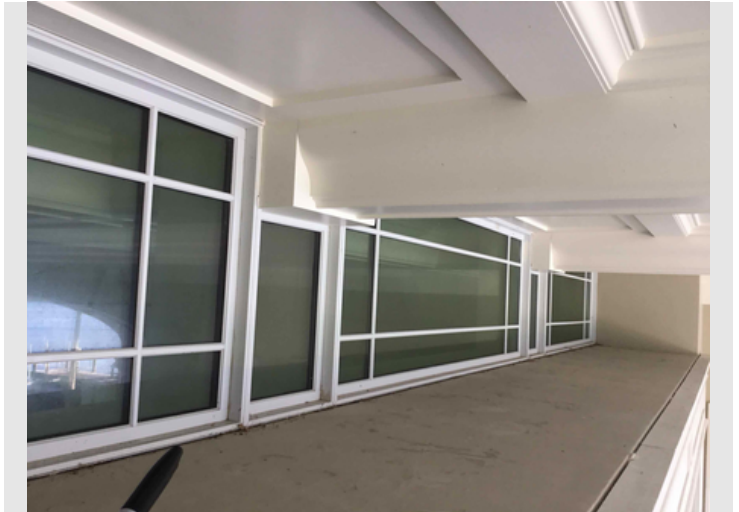
Window "V" fixed (Great Room Transom) close up photo.

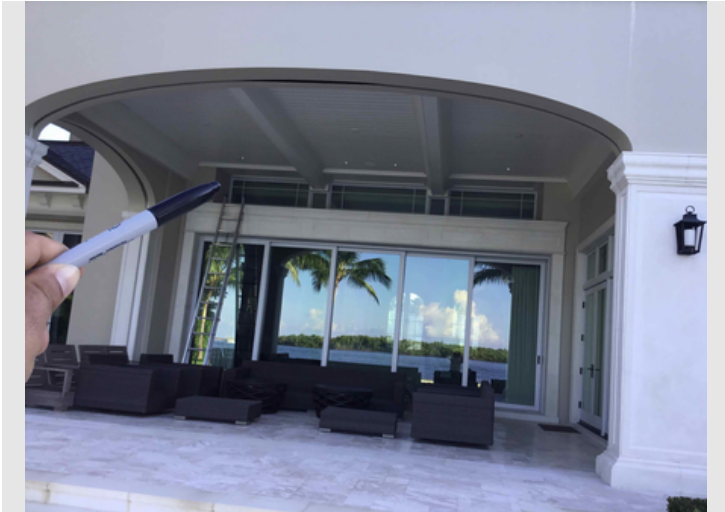
Window "V" fixed (Great Room Transom) missing exterior beauty caulk bead around window, see close up photo.

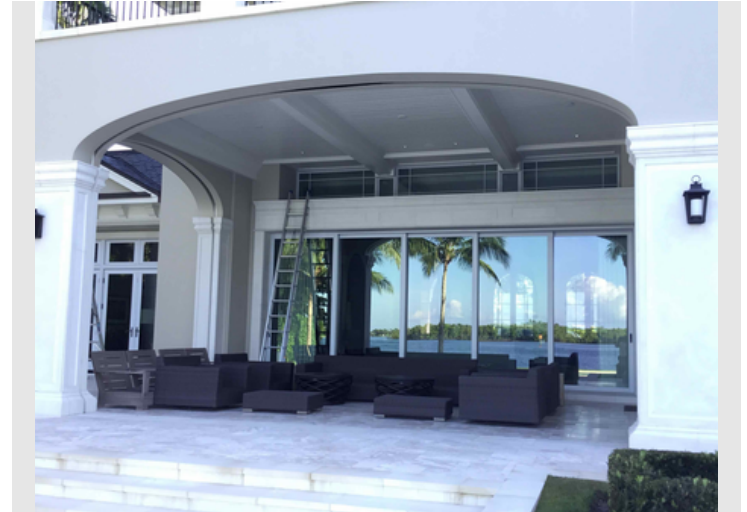
Sliding Glass Door #6 (Great Room), no issues found.

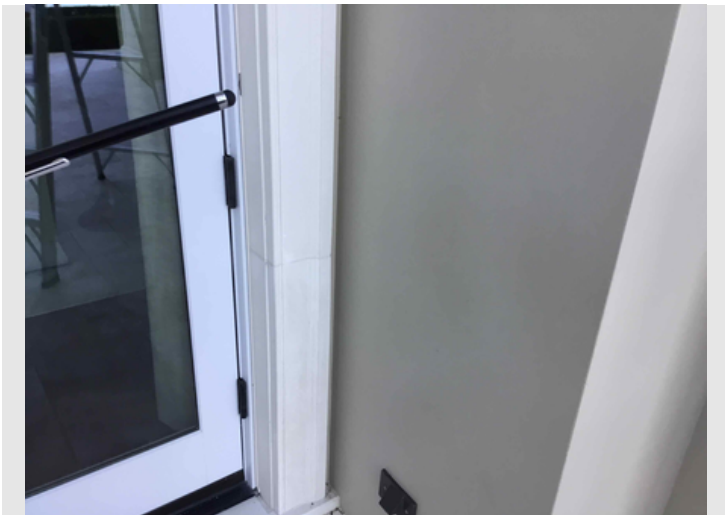
Door #5 (Study), close up photo.

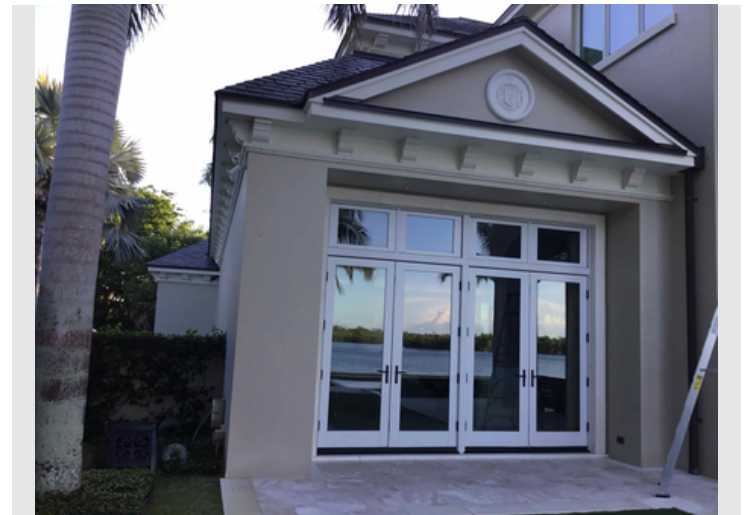
Door #5 (Study), right side beauty caulk bead missing on a small section, see close up photo.
