SULLIVAN RESIDENCE
 620 ADMIRALY PARADE
 PORT ROYAL NAPLES, FL PERMIT 08-15-12

BCB – Sullivan’s Residence, 620 Admiralty Parade, Port Royal Naples, Florida

UNIT VV – SECOND FLOOR, SOUTH REAR ELEVATION

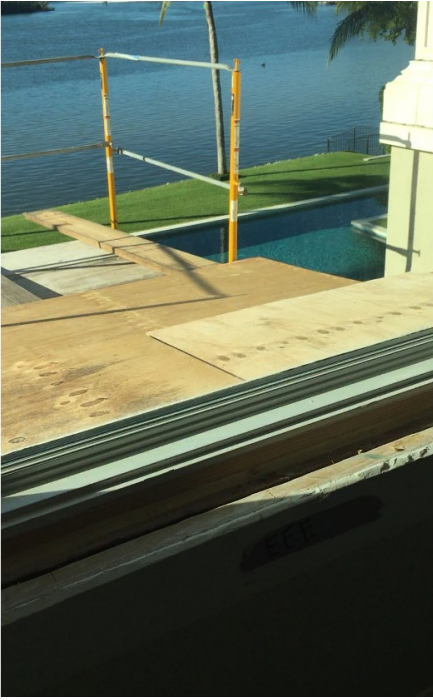
UNIT EEE – SECOND FLOOR - NORTH FRONT ELEVATION

- Sides and top nail fin fastened with Screws and ext. nail fin covered with Pink Joint & Seam Seal (Prosoco Product).

- White Caulking applied to perimeter of interior window, all 4 sides.
- No rot found on perimeter of frame.
- No rot found on sash of operable units.
- Two jamb screws at head/sill/sash. Removal of stops to remove screws, to remove window.
