BCB – Sullivan’s Residence, 620 Admiralty Parade, Port Royal Naples, Florida

UNIT VV – SECOND FLOOR, SOUTH REAR ELEVATION

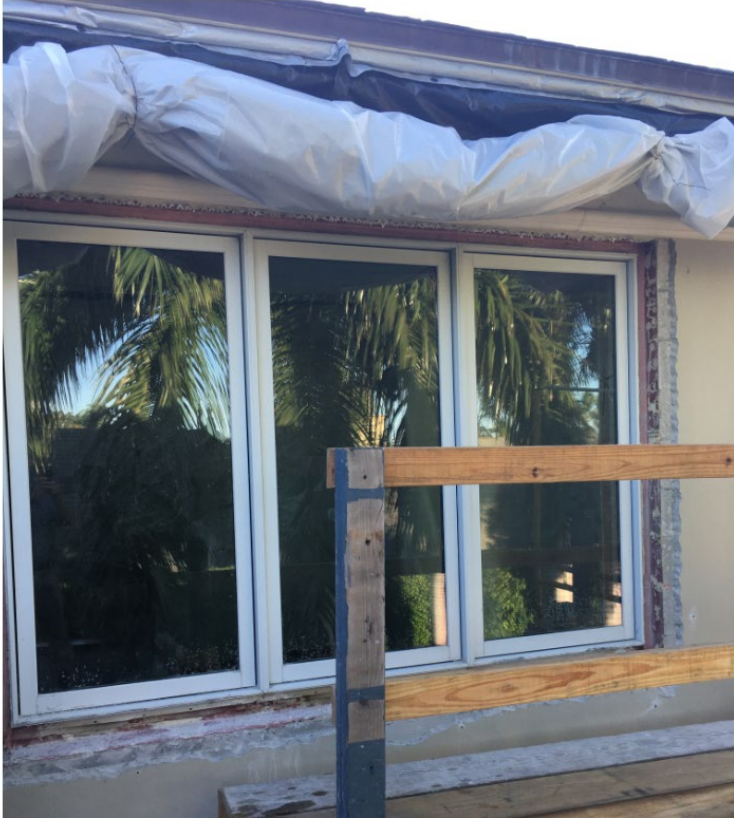
EXTERIOR OBSERVATION

- Sides and top nail fin fastened with screws and ext. nail fin covered with Pink Joint & Seam Seal (Prosoco Product).

- Previous inspection with BCB in September 2020 - BCB probing method concluded that VV had signs of rot. This unit has no evidence of rot. VV had spacers that showed blackening. Some screws were rusted.
- Cause – bottom nail fin was not secured, and no sealant was applied.
